FLOOD EMERGENCY REPORT

JAN. 13 THROUGH JAN. 17, 1978

SANTA CLARA VALLEY WATER DISTRICT

FLOOD EMERGENCY OPERATIONS

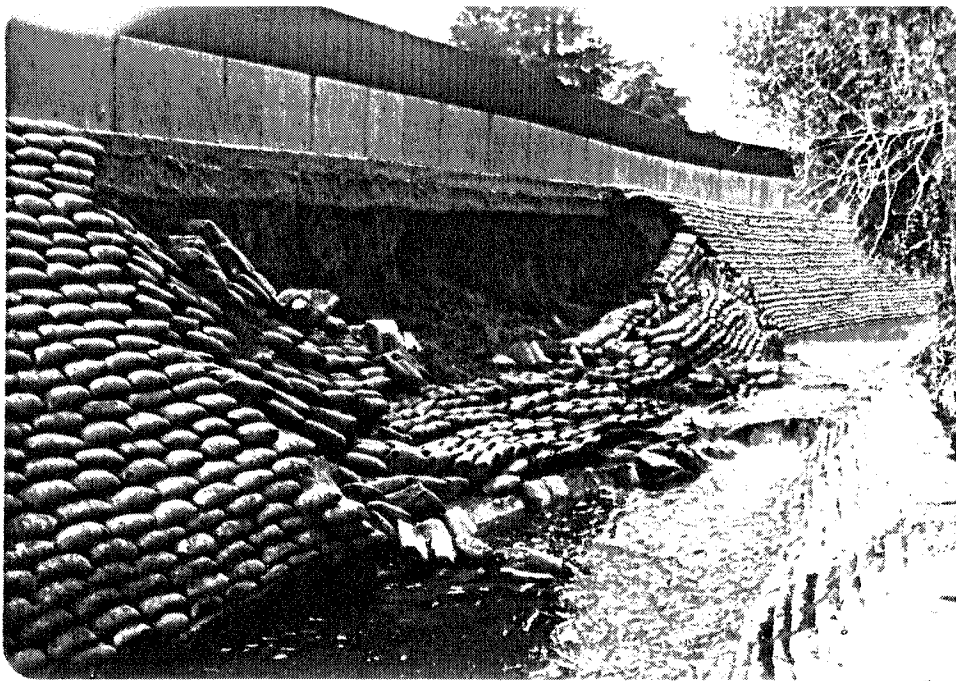
A riprap structure was undermined and failed during the storm. This is San Tomas Aquino Creek along Silacci Drive just upstream of McCoy Avenue.

San Tomas Aquino Creek - Extensive concrete riprap failure accompanied by potential floodwall failure occurred upstream of McCoy Avenue. A thirty-foot length of sanitary trunk sewer line was exposed upstream of Avon Lane. Sandbag and concrete repairs were made at various locations on January 18, 1978. Also, several trees were removed from the creek. Estimated cost of this work is \$35,000.

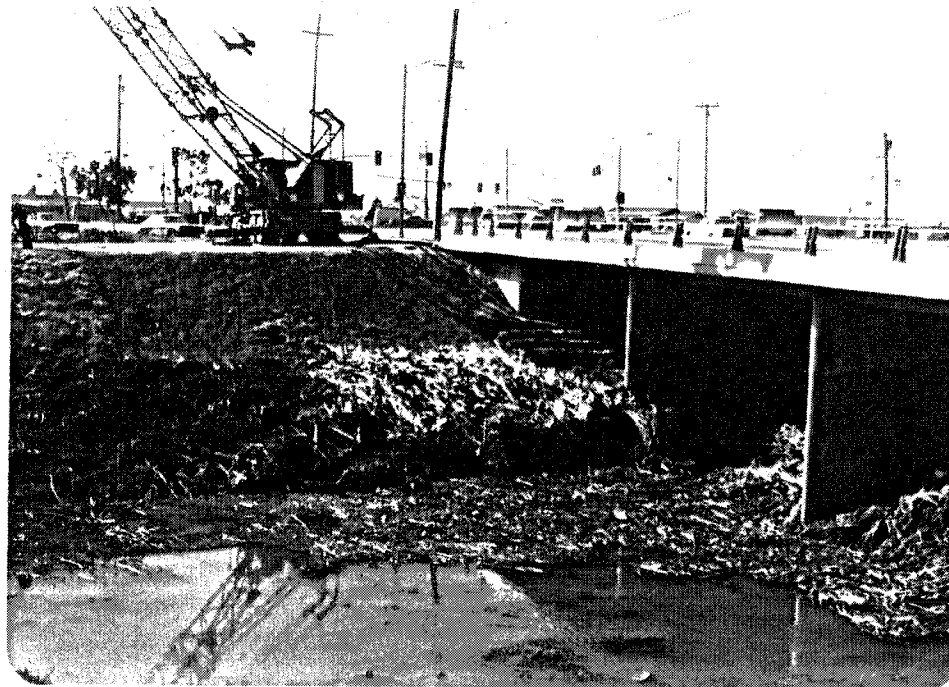
Debris and vegetation removal occupied a large part of the time of maintenance crews.

Shown here is Guadalupe River at Branham Lane bridge. The crane on the bank was rented to remove the debris.

Guadalupe Creek/River - There was a substantial tule and bamboo blockage at the Branham Lane Bridge which was removed. Also, other debris and vegetation removal was required along the creek. A retaining wall along Creek Drive has failed and will need to be replaced. The concrete work at Malone Road failed and will also need to be repaired. The estimated cost for this work is \$20,000.

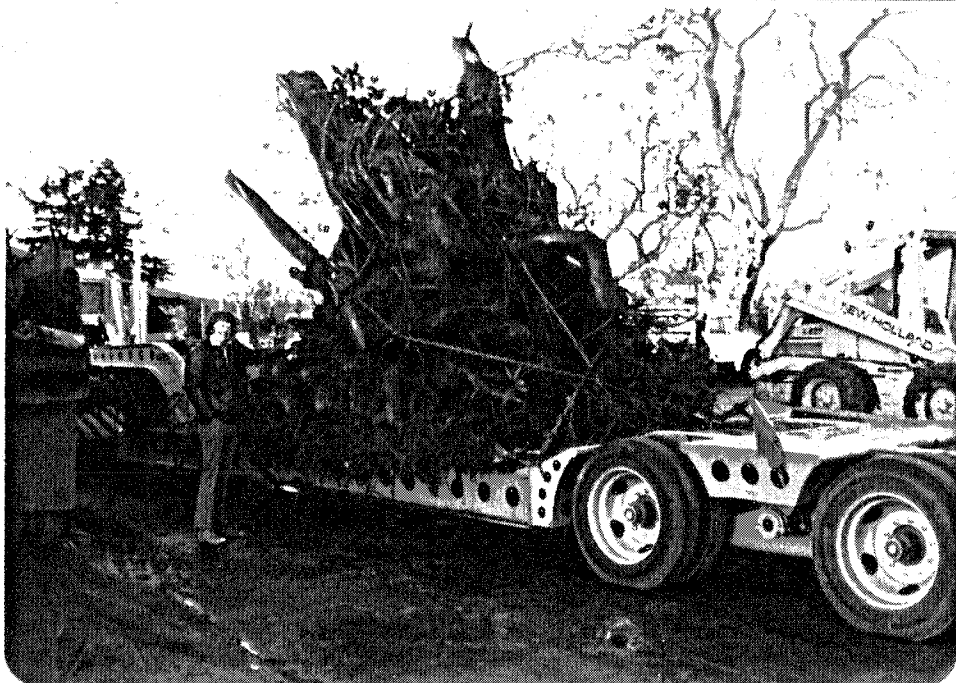
Trees in the bottom of many creeks caused major blockages to flow and required removal. Shown here is the trunk of a tree removed from San Francisquito Creek downstream of Chaucer Avenue.

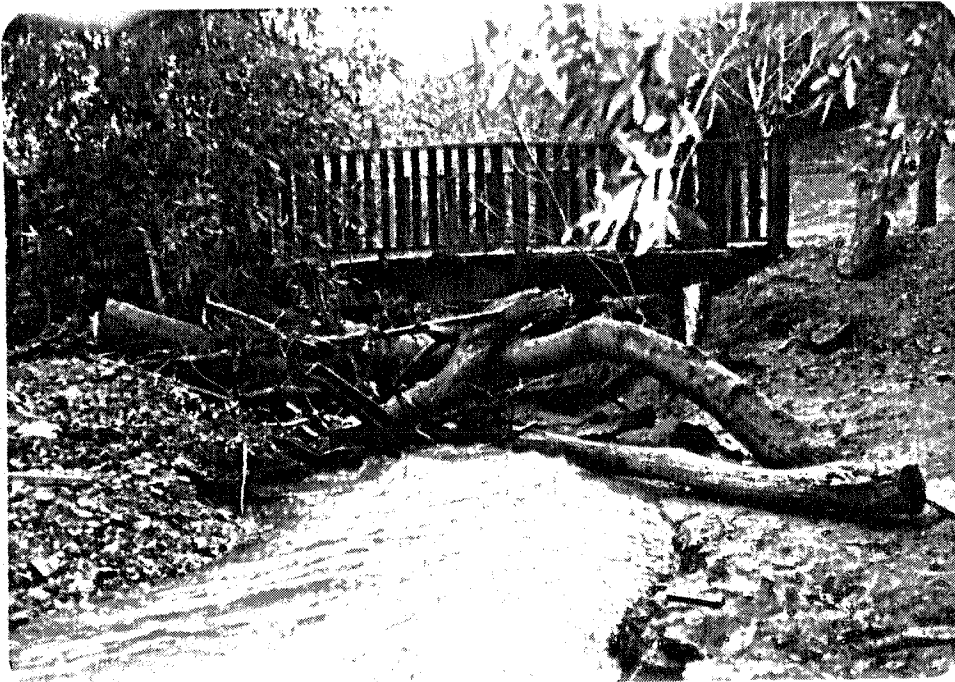
Many District creeks had debris and tree blockage problems similar to the one shown in this photo.

This is Permanente Creek upstream of Foothill Expressway.

Permanente Creek - Silt removal and tree work is required in this channel. Estimated repair cost is \$10,000.

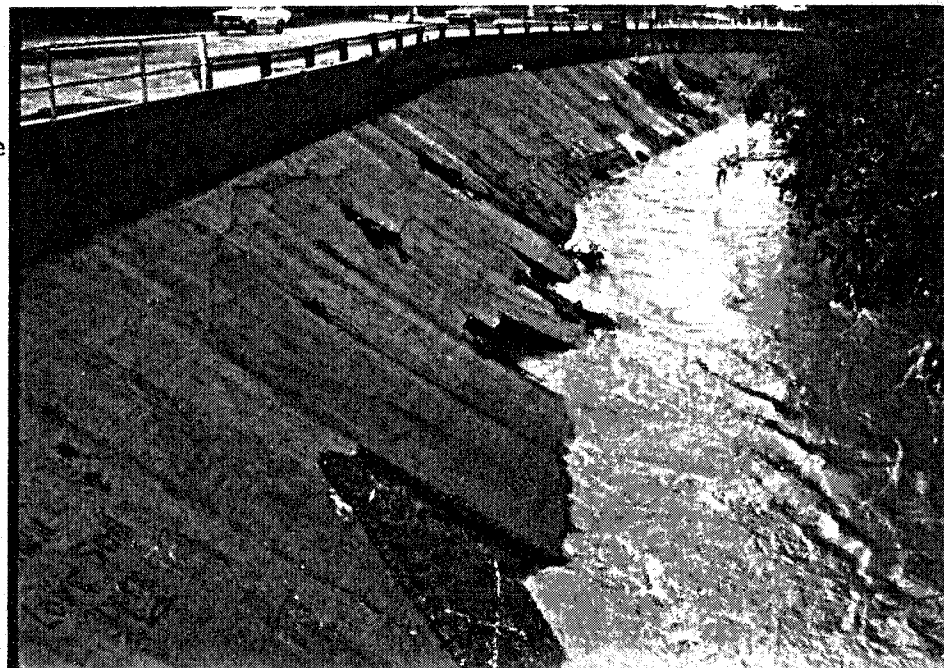
This old structure is showing its age. This is Guadalupe River upstream of Malone Drive. The lining is beginning to fail and erosion is occurring behind the wall.

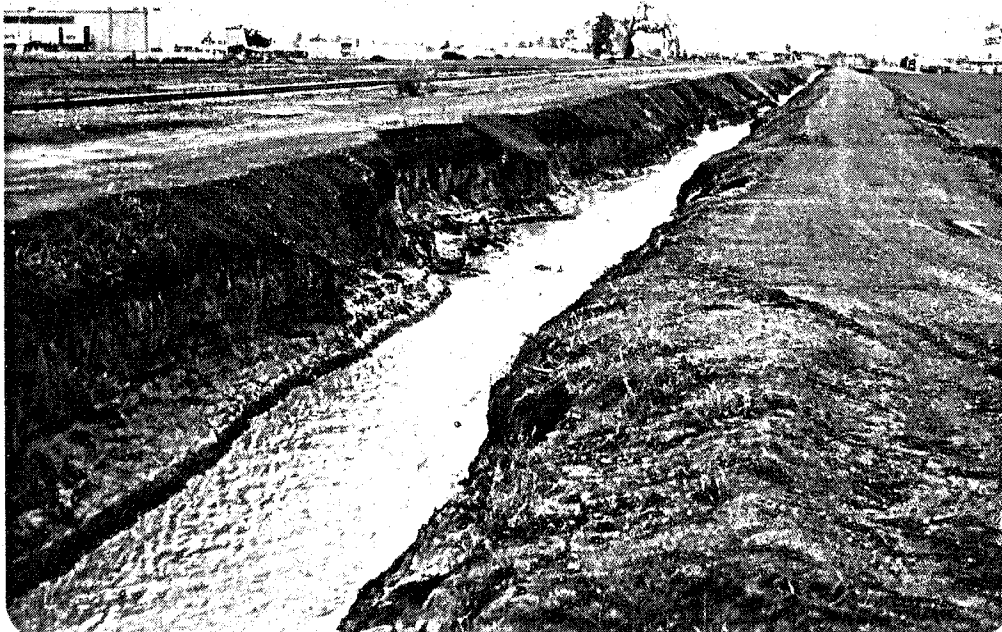
Erosion damage similar to that shown in this photo constituted a good part of the damage imparted by these storms.

Shown here is Berryessa Creek looking upstream from Yosemite Avenue.

Berryessa Creek - Downstream of Old Piedmont Road extensive erosion damage was incurred. Estimated cost to repair is \$5,000.

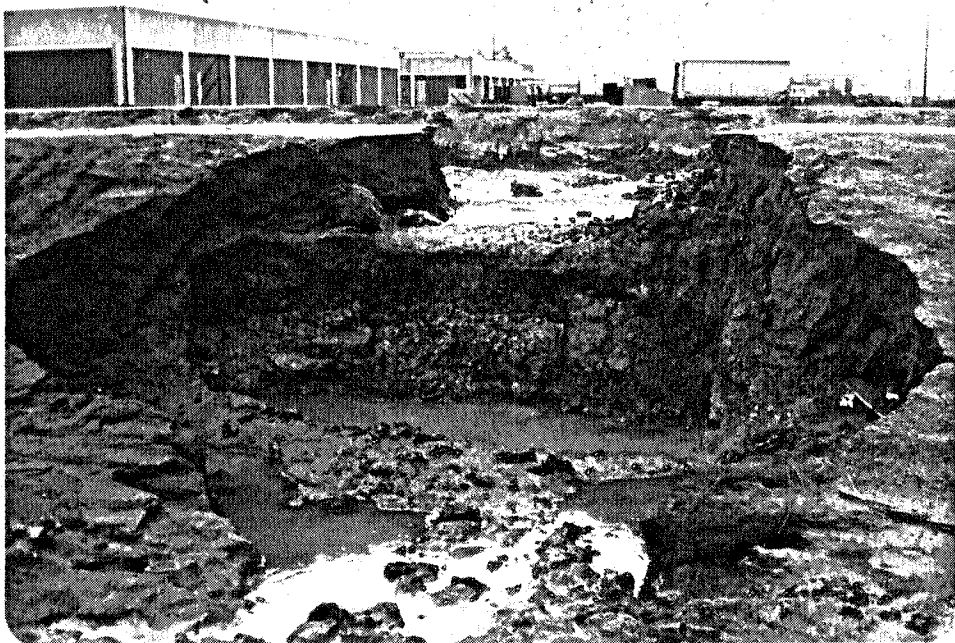
Damage was extensive on the levees along Calabazas Creek between Tasman Drive and Old Mountain View-Alviso Road.

Shown here is typical bank erosion which occurred in the east bank levee.

A great deal of maintenance activity took place between Tasman Drive and Old Mountain View - Alviso Road. Work began at 11:00 p.m. on January 14, 1978 on the easterly side of the creek. District forces attempted to stop flows across the road into Edelweiss Dairy. They began placing sandbags at three of the gate entrances to the dairy at 12:30 a.m. on January 15, 1978. At 8:00 a.m. on January 15, 1978 sandbagging was started on the levee low spots on the westerly side of the creek. At 4:00 p.m. January 15, 1978, sandbagging repairs on the breach near Tasman Drive along the easterly side of the creek began. There were at least nine more breaches and overtopping sections on the easterly levee that required work. In addition to District forces the equipment rental contractor provided labor for this work. Sandbagging continued until 3:30 p.m. on January 17, 1978, at which time flows subsided and the need for sandbags disappeared.

The estimated cost to repair the damages and replace the levee on Calabazas Creek is \$90,000.

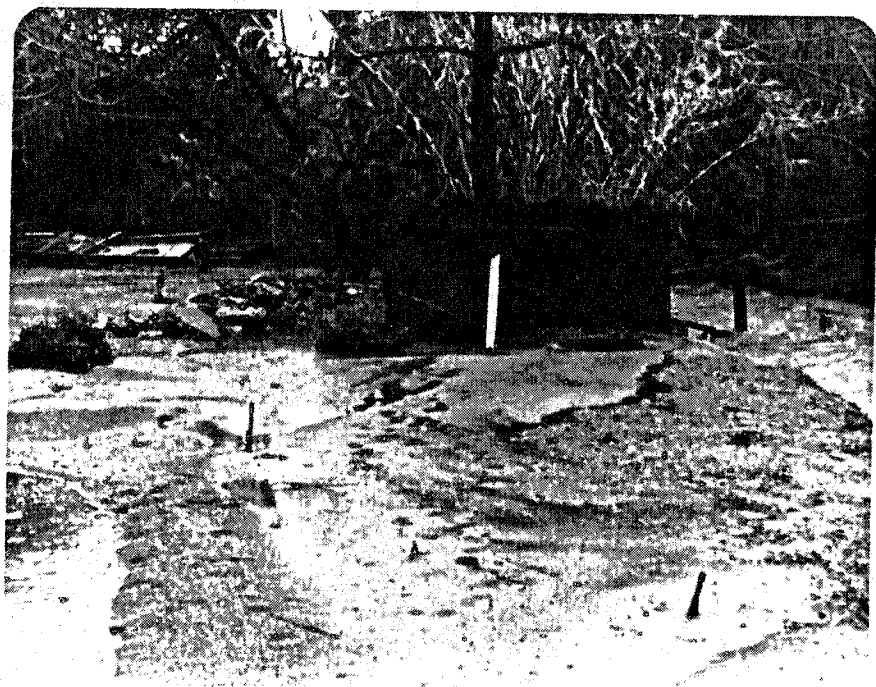
Ross Creek overtopped its banks downstream of Blossom Hill Road and Cherrystone Drive. As shown in this photo the back yard of 16130 Lilac Drive was inundated and fences were destroyed.

Ross Creek - Immediately downstream of Topping Way, the U-frame channel was overtopped. Flood fighting efforts concentrated on preventing damage to the adjacent property during the storm. To prevent major flooding of adjacent properties, maintenance crews placed sandbags along the creek upstream of Blossom Hill Road on January 19, 1978. Estimated cost to repair was \$25,000.

Ross Creek Downstream of Blossom Hill Road - On January 14, some four homes on Cherrystone, Winterbrook and Lilac Avenues were threatened with flooding. This flooding was predicted before the homes were built. The Town of Los Gatos chose to retain ownership of the creek right of way in this area. A tree in the center of the creek is the cause of some of the problem. Homeowners do not want this removed.

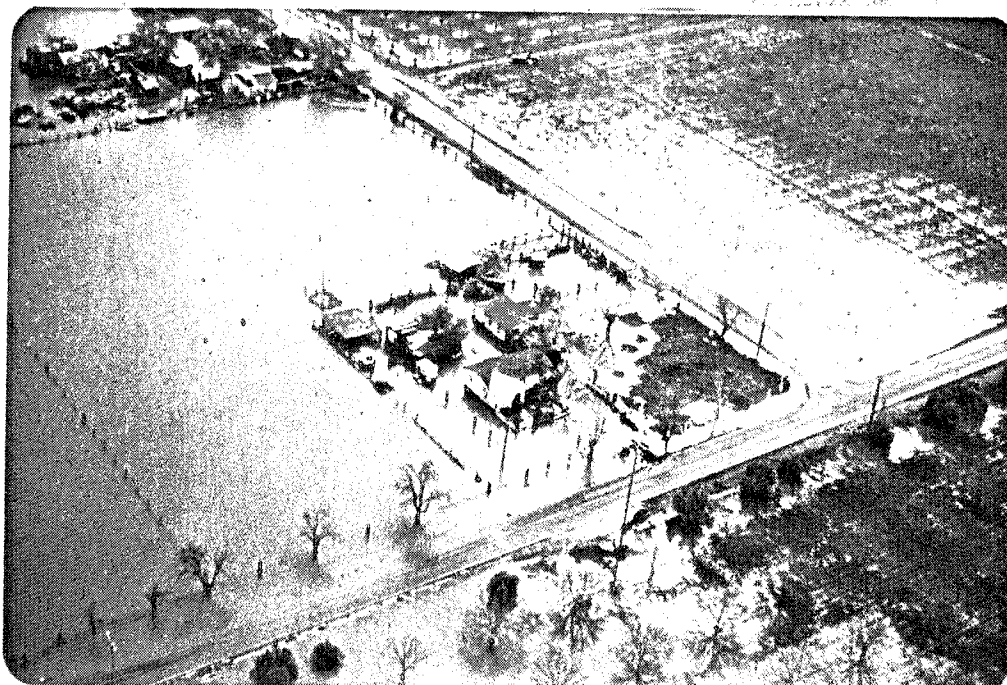
Jan. 16, 1978

Local drainage was a problem in several areas throughout the county. Shown here is the intersection of Hill Road and Main Avenue in Morgan Hill.

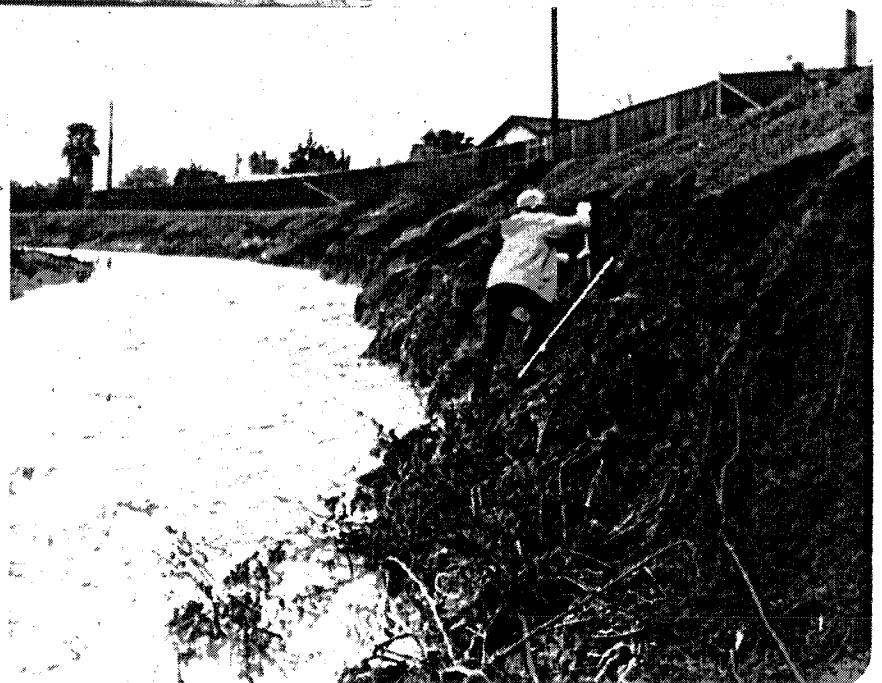
High flow staking allows the flow in a channel to be determined after the water level has fallen and rain has stopped.

Shown here is a storm patrol team member staking Saratoga Creek at its confluence with San Tomas Aquino Creek on January 16, 1978.

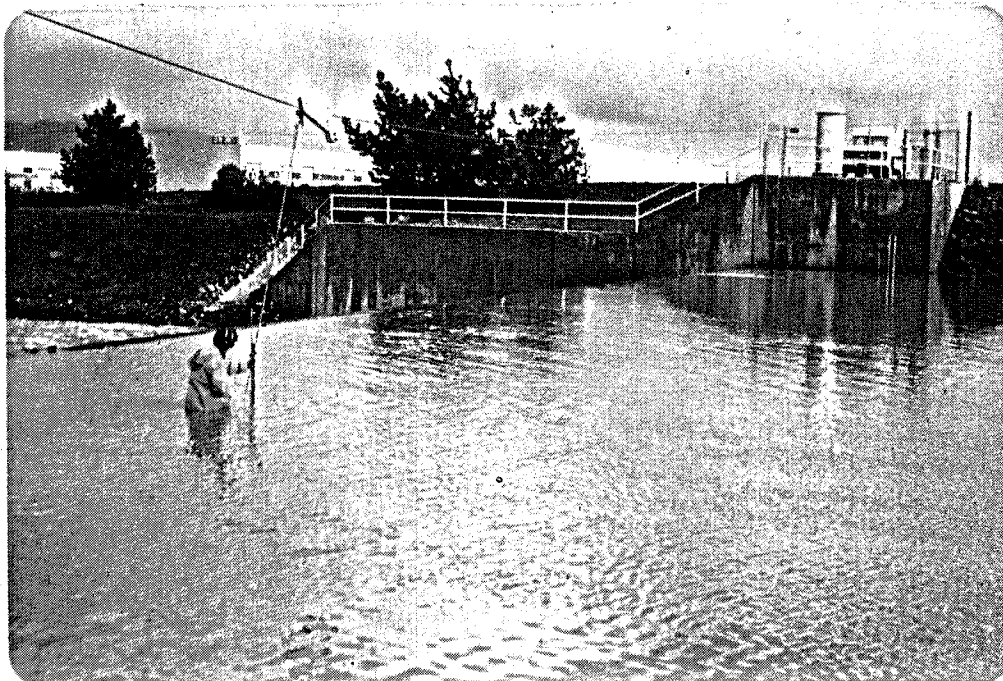
Gathering data on creek flows is one of the prime goals of the data collection group during a storm.

Shown here is a stream gager just upstream of the drop structure on Guadalupe River at the District's main facility.
