PART III //

HISTORICAL LANDSCAPE CONDITIONS AT THE LOCAL SCALE

Part III examines conditions prior to Euro-American modification in more detail, focusing on channel morphology, wetland types, plant communities and their controlling physical processes. We also describe the evidence supporting these interpretations.

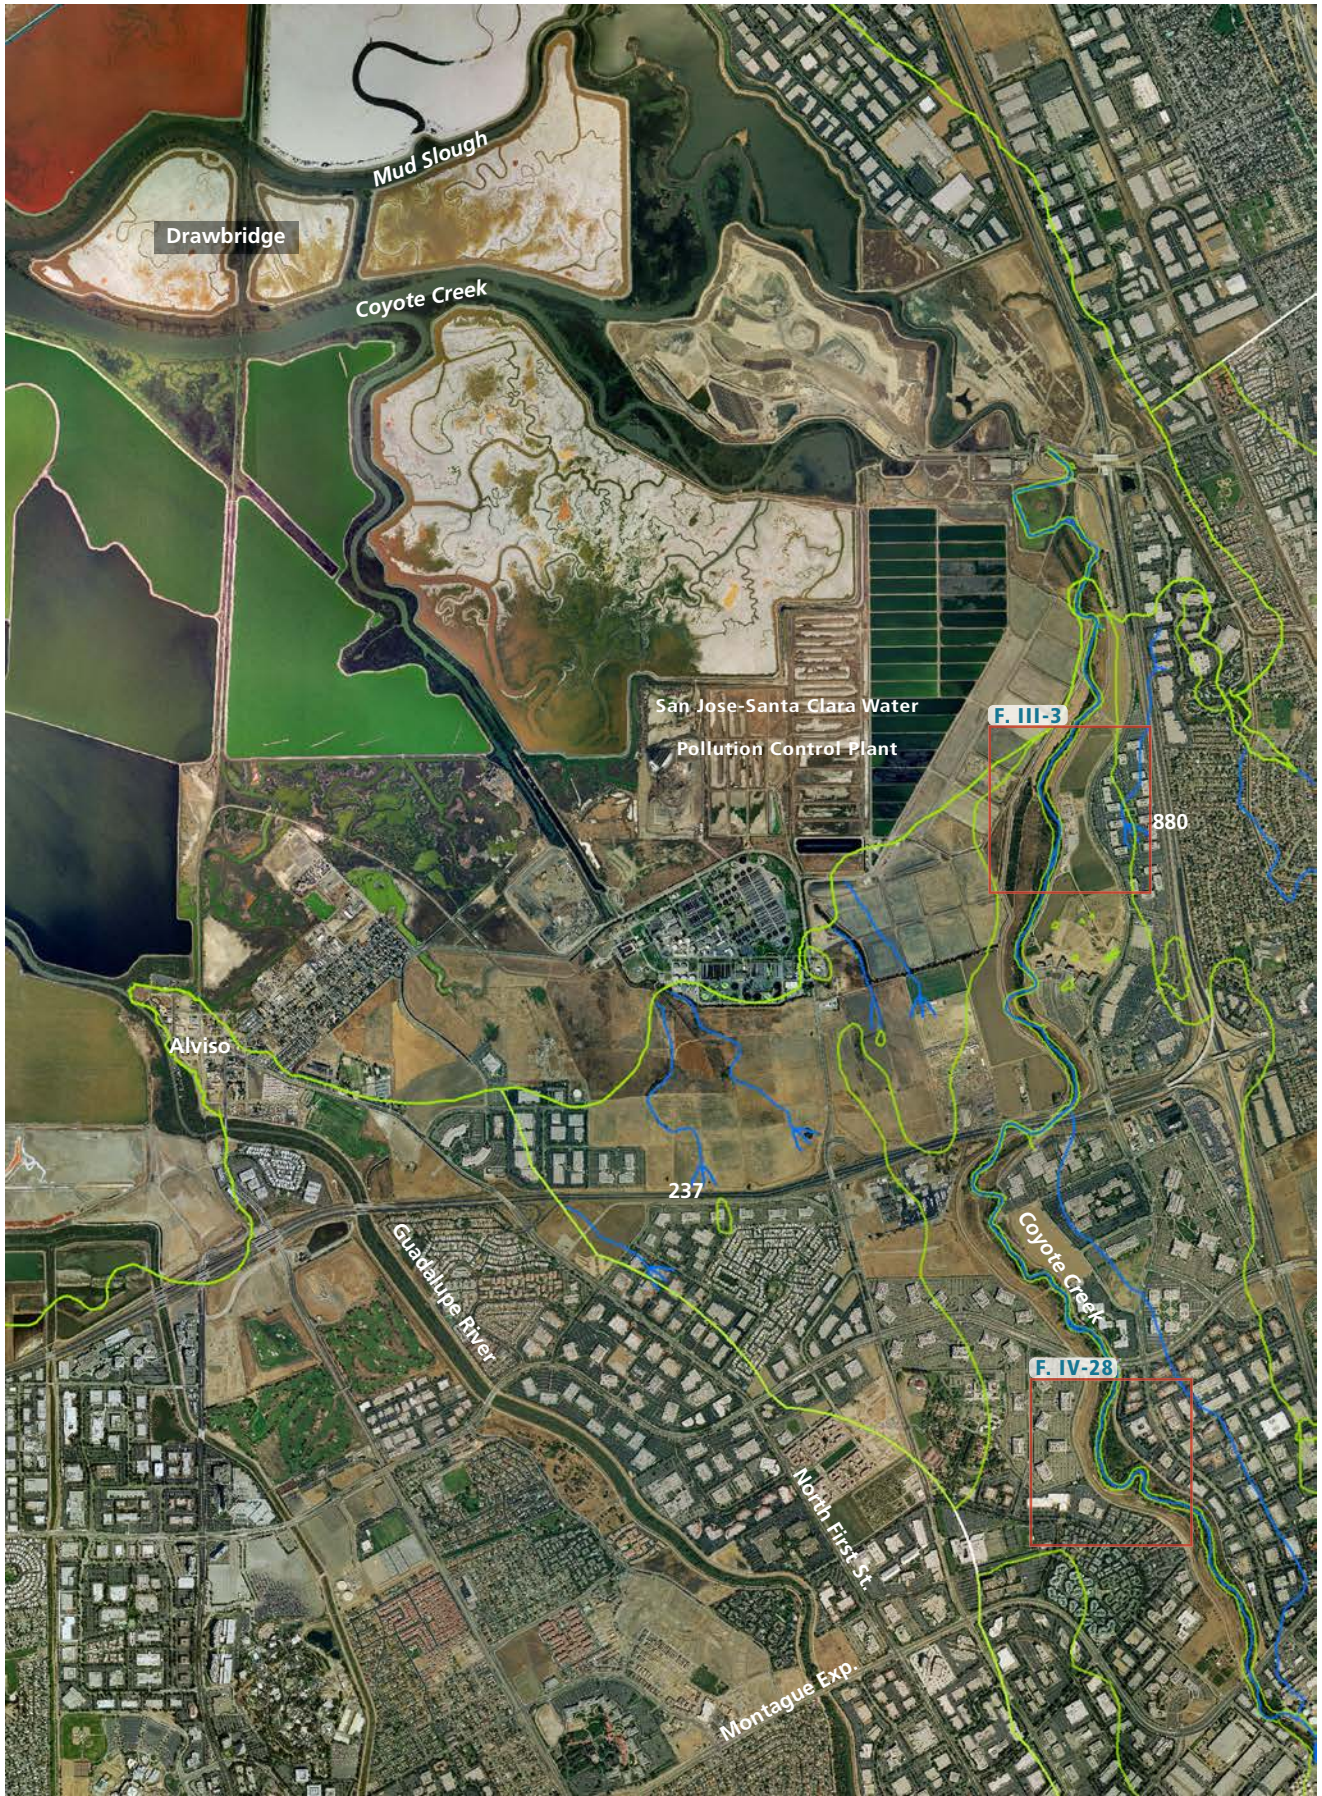
MAP 1A-2002. MODERN AERIAL IMAGERY, WITH HISTORICAL LANDSCAPE FEATURES OVERLAY. Historical fluvial features in blue; other features, green; project boundary, white (scale 1:40,000; 1"~3300'; Imagery Copyright 2005 AirPhotoUSA, LLC, All Rights Reserved).

In the Lower Coyote Creek Area, Coyote Creek’s natural levee extends across the lower valley floor and into the Baylands. Prominent natural levees follow the creek’s present and former routes. The smaller, steeper alluvial fans of Calera Creek, Arroyo de los Coches, Berryessa Creek, and Upper Penitencia Creek descend from the east side. In between the alluvial fans of the eastside creeks and Coyote, there was a large bottomlands area through which Lower Penitencia Creek meandered.

Willow groves, freshwater marshes, wet meadows, and salt grass-alkali meadows occupied the bottomlands areas. The smaller creeks dissipated on the alluvial plain near their canyon mouths, but the larger creeks —Arroyo de los Coches and Berryessa Creek — maintained defined channels into the bottomlands, where they ended in giant willow thickets. Trees were found along creeks, but outside of the riparian corridors and *sauvals*, most of the area was a treeless plain. Wallace describes Rincon de los Esteros: “the land is perfectly level and destitute of timber except on the banks of the creeks” (Wallace 1858: 197). Numerous overflow or secondary channels carried flood flows from Coyote Creek and Lower Penitencia Creek. At the southeastern edge of the area, valley oak savanna appears on the Berryessa and Upper Penitencia Creek fans.

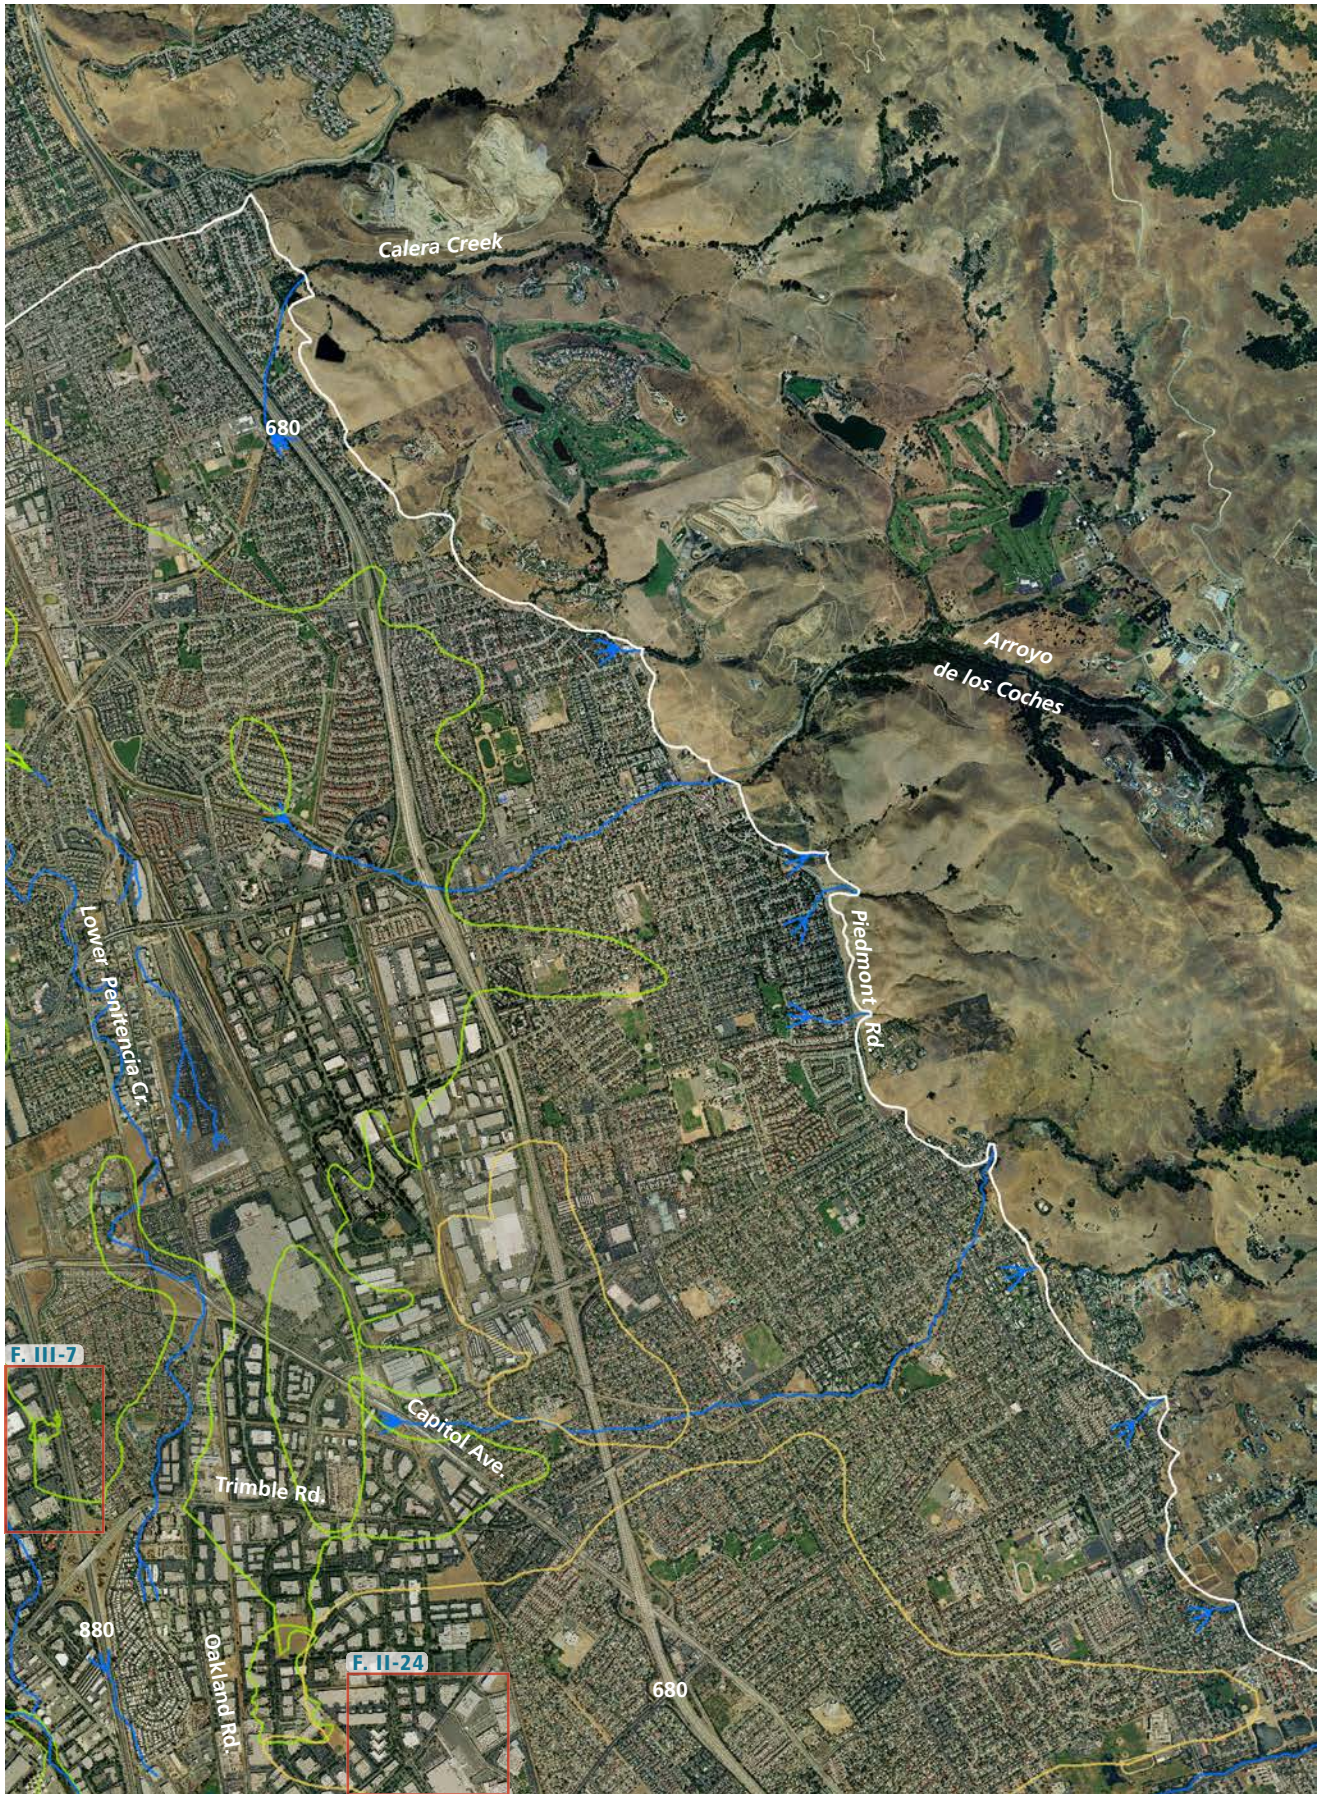
MAP 1B-2002. MODERN AERIAL IMAGERY, WITH HISTORICAL LANDSCAPE FEATURES OVERLAY. Historical fluvial features in blue; other features, green; project boundary, white (scale 1:40,000; 1"~3300'; Imagery Copyright 2005 AirPhotoUSA, LLC, All Rights Reserved).

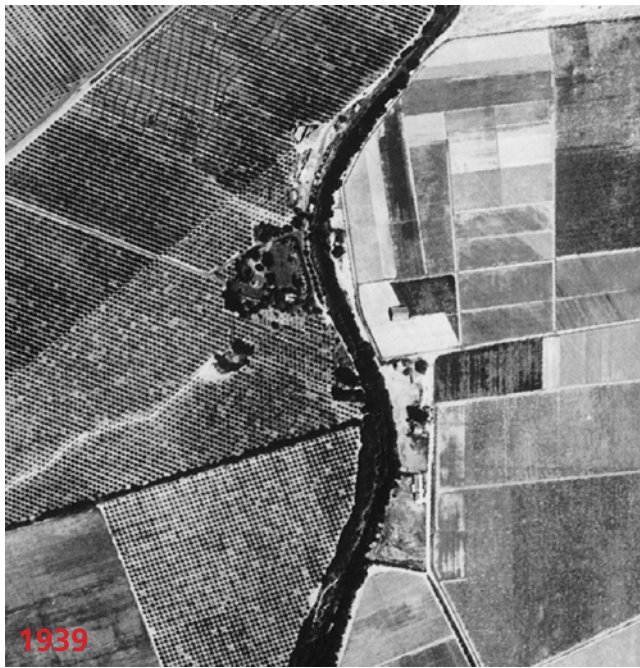
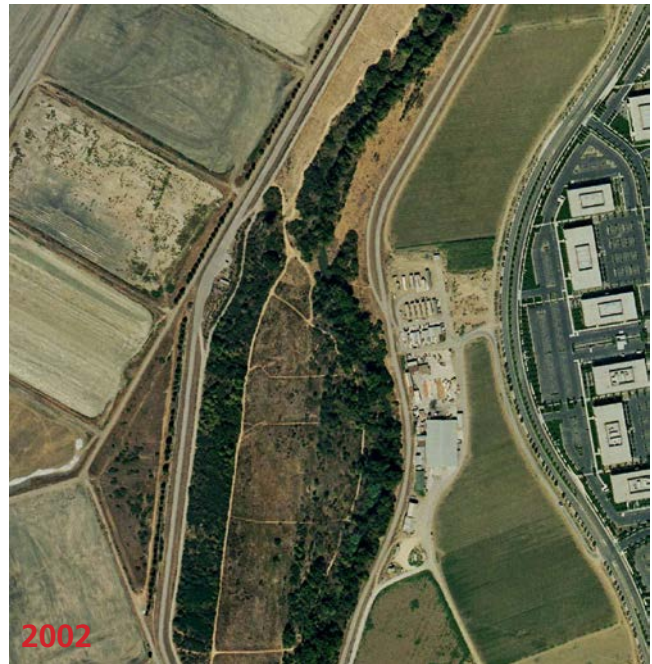
FIGURE III-3. SEQUENTIAL IMAGES OF LOWER COYOTE CREEK ADJACENT TO THE PRESENT-DAY SAN JOSE-SANTA CLARA WATER POLLUTION CONTROL PLANT. These data illustrate conditions in 1874 (lower left, Herrmann 1874, courtesy Santa Clara County Surveyors Office), 1897 (lower right, Westdahl & Morse 1896-97, courtesy National Ocean Service), 1939 (upper left; AAA 1939), and 2002 (upper right; Imagery Copyright 2005 AirPhotoUSA, LLC, All Rights Reserved). These views indicate a nearly continuous, narrow riparian corridor that has persisted through time, with some expansion in recent decades. This reach is also the likely location for the following landscape photographs by Hare circa 1905 (FIGURE III-4).

by Herrmann (1874c), Westdahl & Morse (1896-97), and early aerial photography (FIGURE III-3).

Coyote Creek (FIGURE III-5, see also FIGURE III-3). It appears from comparison of historical maps and photographs that riparian forest has extended slightly farther downstream during the past 130 years. This may be due to reduced tidal prism resulting from diking. It is notable that the downstream extent of the riparian forest has persisted (or increased) despite the dramatic decreases in local groundwater levels during the mid-20th-century. This may reflect the reliability of groundwater emergence into the lower reaches of the channel.

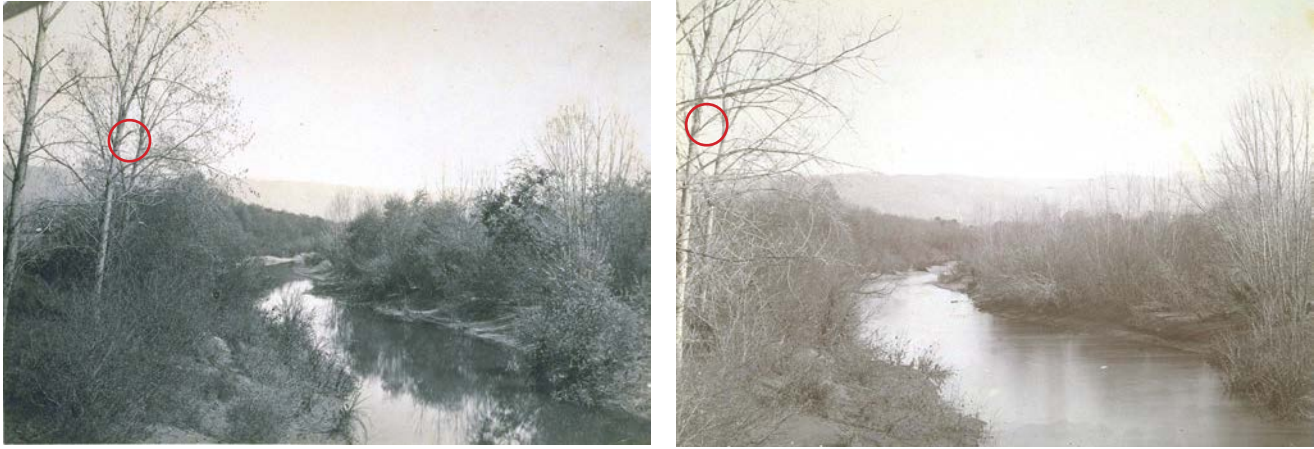
FIGURE III-4. LOWER COYOTE CREEK CIRCA 1905. These images were titled “A winding stream near Milpitas Cal.” and “Coyote Creek near San Jose” but examination of the trees at left indicates that they were taken from the same location at different times. Broken branches indicate that the image on the left was taken later (Hare ca. 1905a&b, courtesy The Bancroft Library, UC Berkeley).

A pair of photographs taken by the noted artist Alice Iola Hare illustrates these general conditions on Coyote Creek at the turn of the 20th century (FIGURE III-4). While levees had been constructed along the creek upstream of Highway 237 by this time (Westdahl & Morse 1896-97), these photographs appear to have been taken downstream of Highway 237 (accordingly, one of the captions specifies “near Milpitas”). Taken at two different times of year, the photographs show shallow, sinuous channel with slow-moving water. Riparian vegetation is dense but young, suggesting frequent overflow and disturbance by flood.

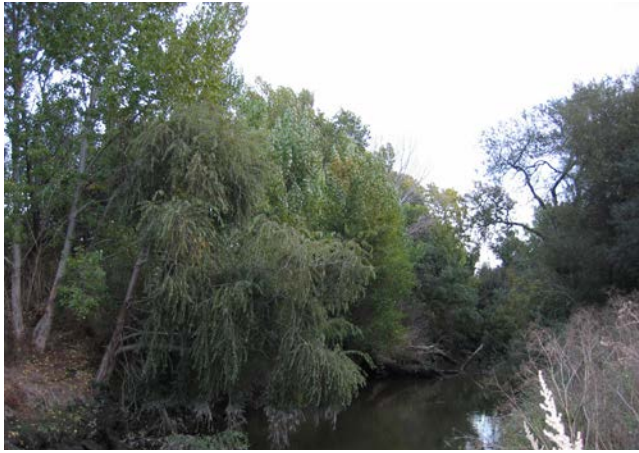
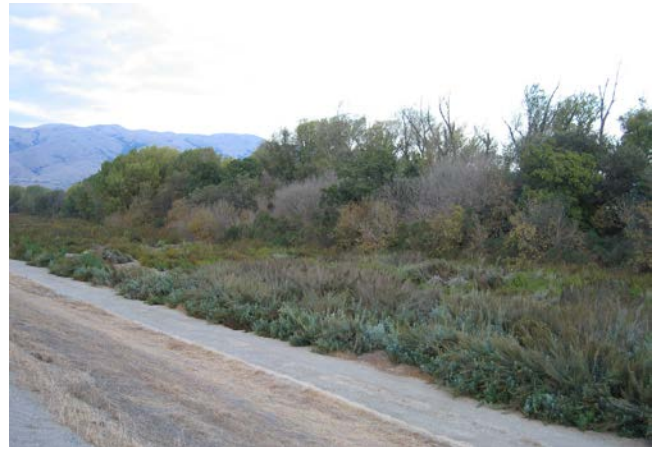
FIGURE III-5. LOWER COYOTE CREEK 2005. These photographs likely approximate the location of Alice Iola Hare's photographs 100 years earlier (facing page).

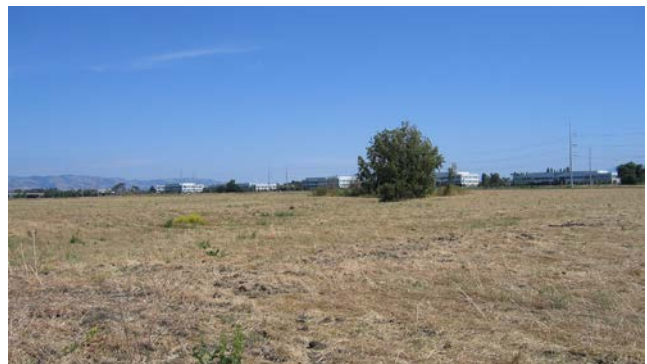
FIGURE III-6. RESIDUAL "SPRING RUN" MORPHOLOGY. A distinct swale indicates a former spring-fed, tidally-influenced channel in the vicinity of the San Jose-Santa Clara Water Pollution Control Plant.

"these sloughs were apparently formed by the overflow from the Coyote, the Tidewater runs in some of them"), and Houghton (1860), who notes that they are "mere gullies caused by the waters of the Coyote overflowing [,] there being a depression in the land about where these sloughs are located." Healy (1860b) clarifies that these channels have tidal flow to a variable point upstream but that the channels themselves "extend into good arable or grass lands upwards of a mile." Remnants of several of these apparently artesian, tidally-influenced features can still be seen in the present-day landscape (FIGURE III-6).

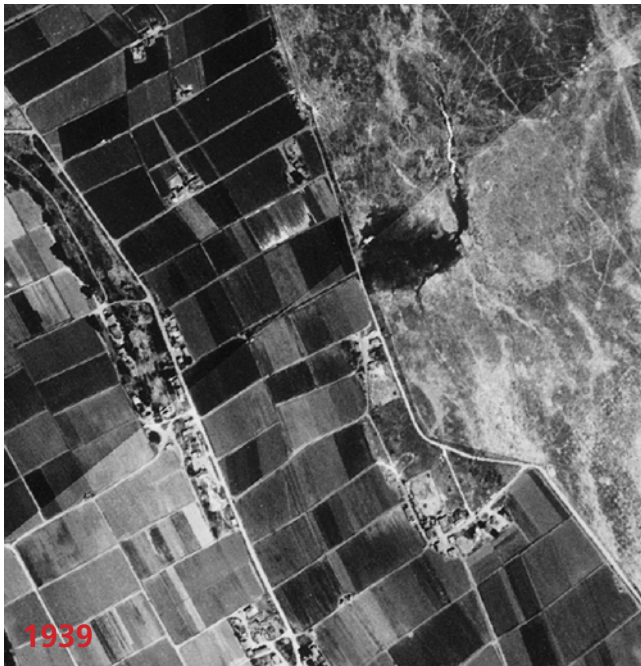
FIGURE III-7. BOTTOMLAND BOUNDARY IN MILPITAS. The 1800 view (lower left) shows dry grassland occupying Coyote Creek’s broad natural levee on the left and alkali meadow, with a perennial freshwater marsh, in the bottomlands to the right. These boundaries are based upon the 1940-41 soil survey (Gardner et al. 1958; lower right), which also generally indicates the small marsh with two wetland symbols. Farmers have developed the well-drained, coarse alluvial deposits in 1939 (upper left; AAA 1939), but poor drainage and salt effects in the bottomland soils have precluded agriculture, forming a distinct land use boundary. The shape of the freshwater marsh is indicated by darker, saturated soils. Highway 880 and the Montague Expressway off-ramp can be seen presently (2002; upper right; Imagery Copyright 2005 AirPhotoUSA, LLC, All Rights Reserved).

were characterized by native grasses, wetland plants, and an array of presently rare plants associated with vernal pools and alkali flats (see description in [PART II](#)). Soil conditions precluded agriculture quite dramatically, forming distinct land use boundaries ([FIGURE III-7](#)).

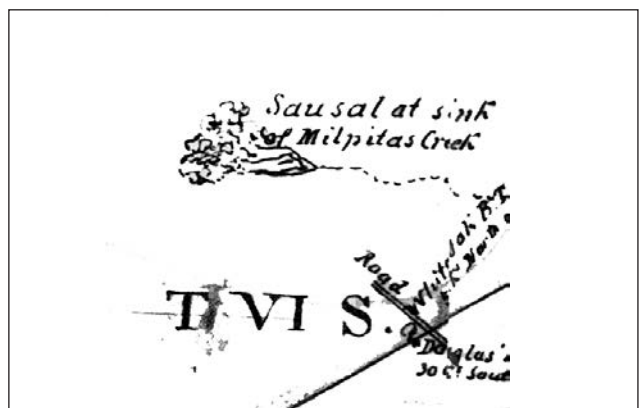
FIGURE III-9. "SAUSAL AT SINK OF MILPITAS CREEK." Berryessa Creek (formerly Milpitas Creek) ended in a willow grove just below today's Capitol Ave. ("Road", Stratton 1862b, courtesy The Bancroft Library, UC Berkeley).

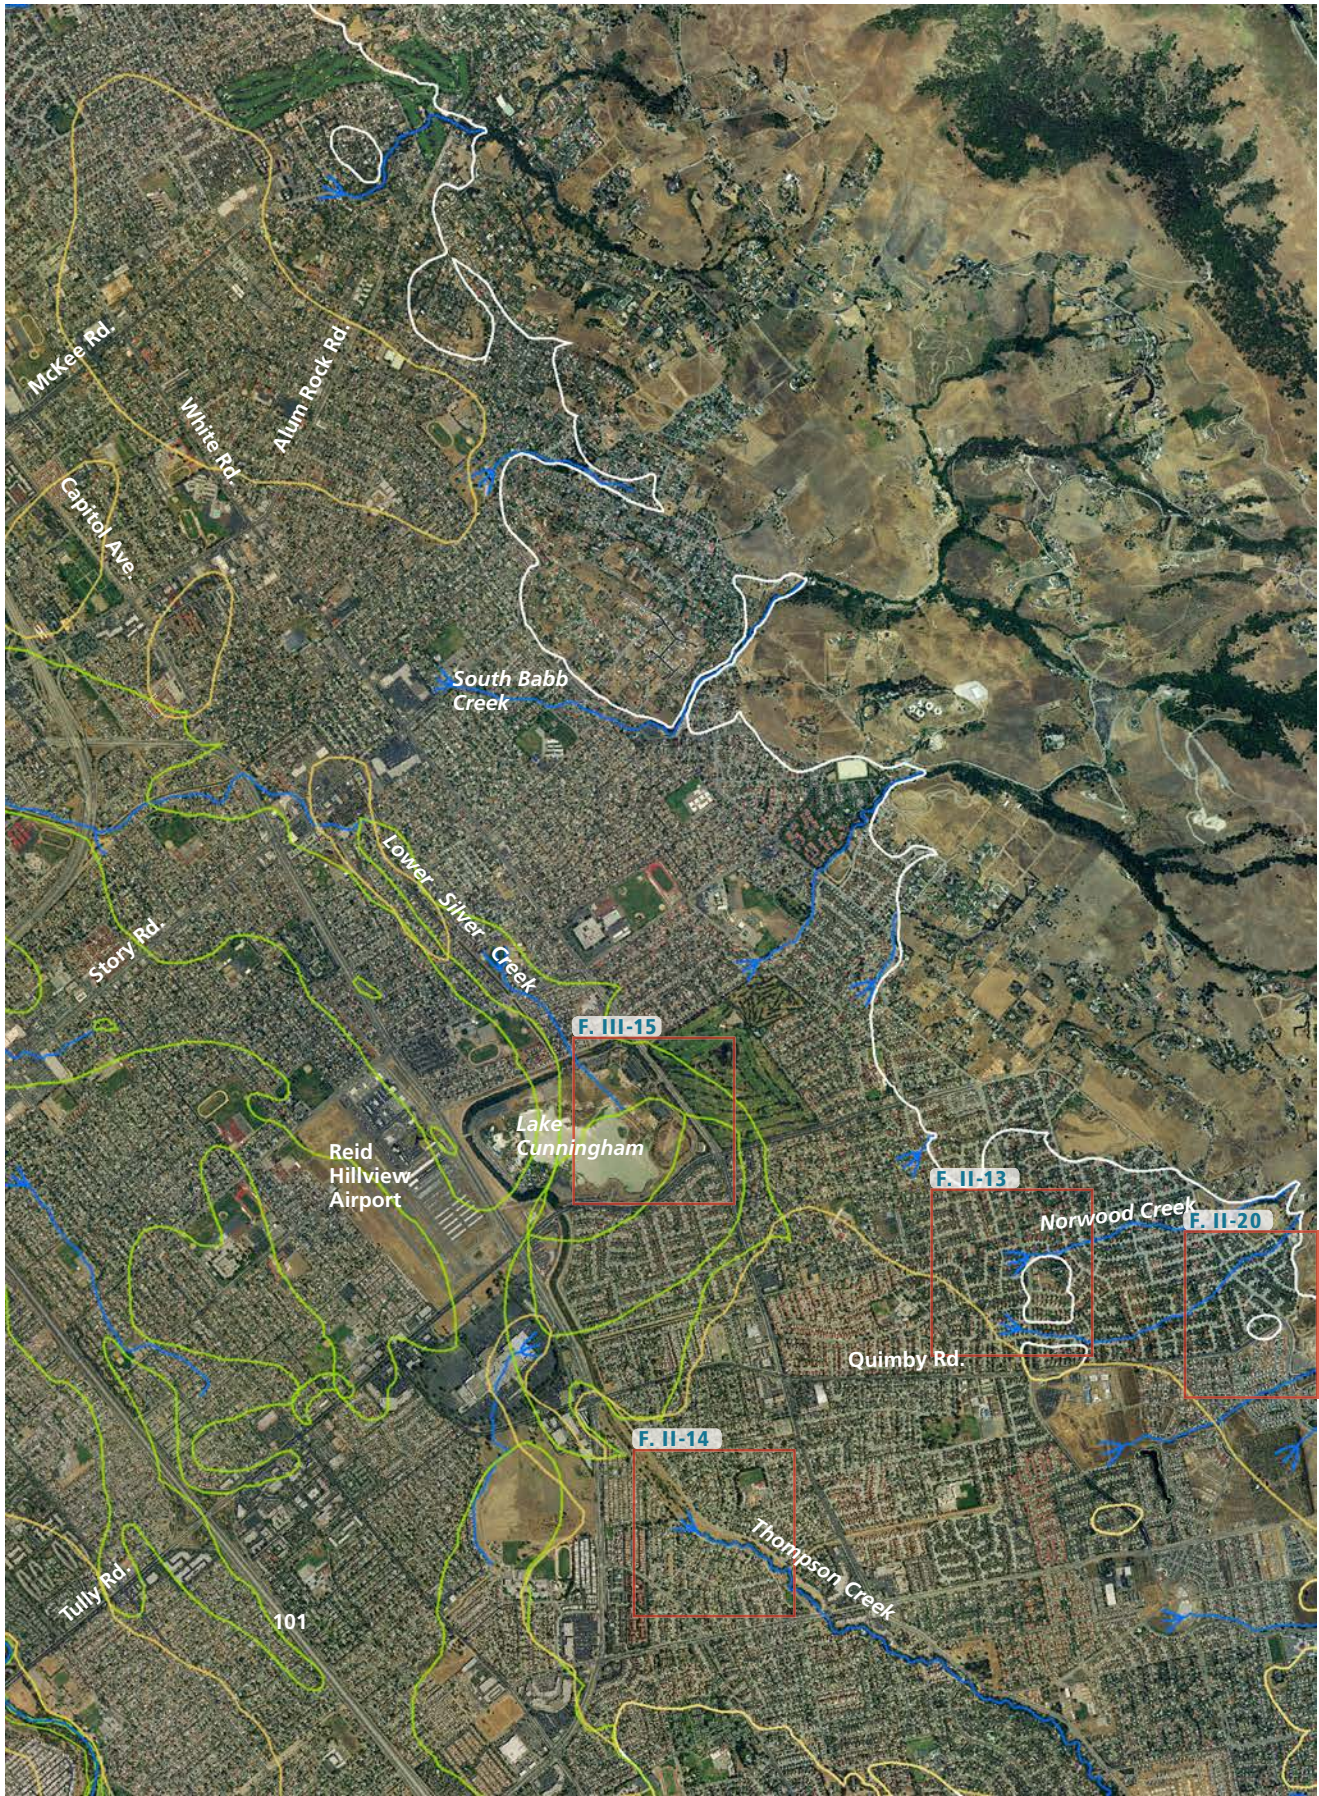
MAP 2B-2002. MODERN AERIAL IMAGERY, WITH HISTORICAL LANDSCAPE FEATURES OVERLAY. Historical fluvial features in blue; other features, green; project boundary, white (scale 1:40,000; 1"=3300'; Imagery Copyright 2005 AirPhotoUSA, LLC, All Rights Reserved).

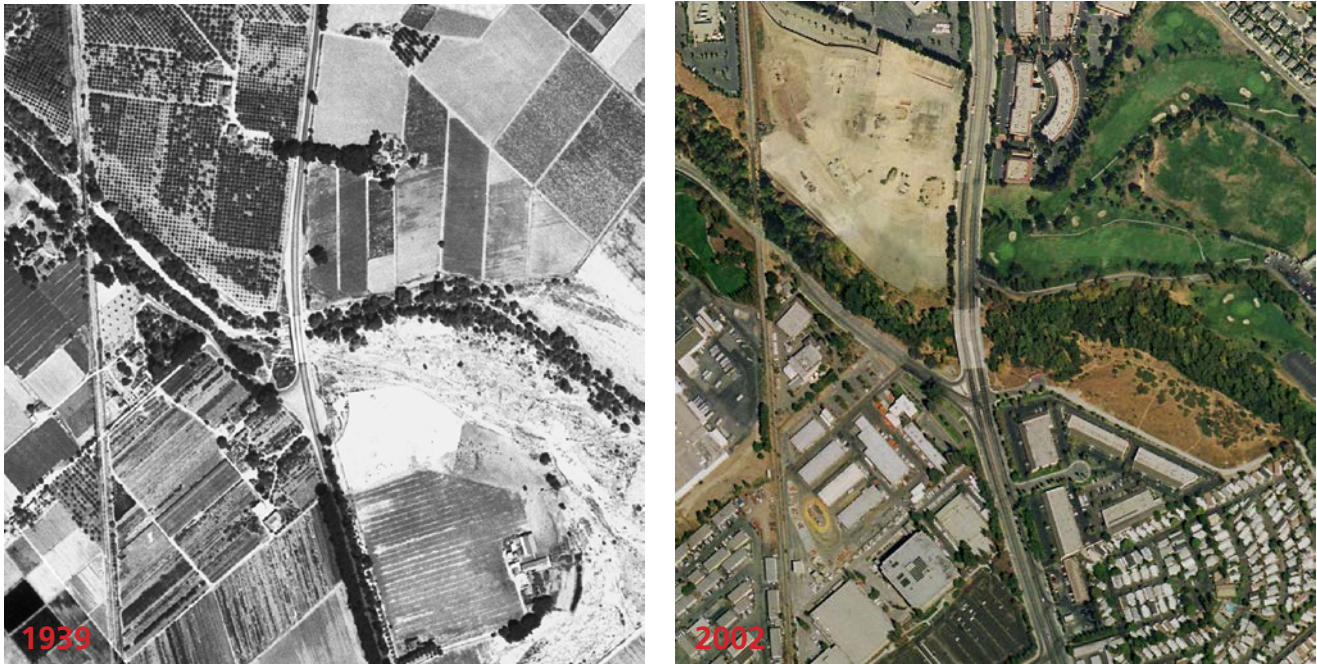
FIGURE III-10. COYOTE CREEK AT OAKLAND ROAD IN 1939 (LEFT) AND 2002 (RIGHT). Long-standing crossings such as Oakland Road (center, running north-south in each image) and the Southern Pacific Railroad (left side) were established at this short, naturally narrow reach. On the right side of the 1939 image (AAA 1939), a broad active channel area can be seen in the form of scour patterns and unvegetated areas excluding agriculture. These stream benches are now occupied primarily by the South Bay Mobile Home Park, which has been subject to flooding, the San Jose Golf Course, and the North Coyote Park (brown area at middle right, 2002 Imagery Copyright 2005 AirPhotoUSA, LLC, All Rights Reserved), which provides some undeveloped floodplain capacity.

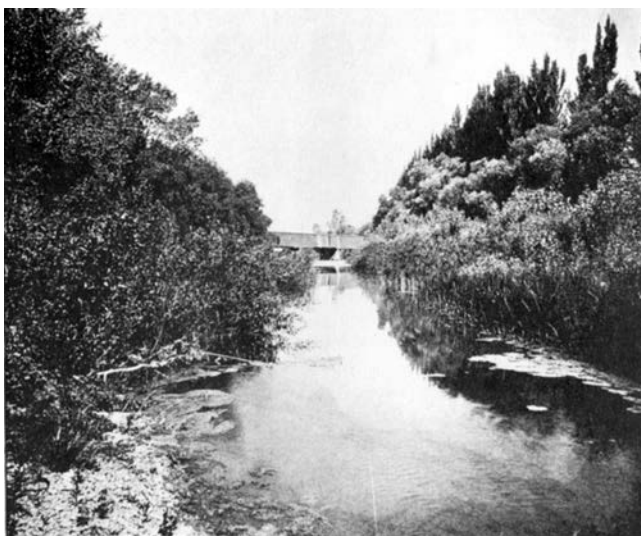
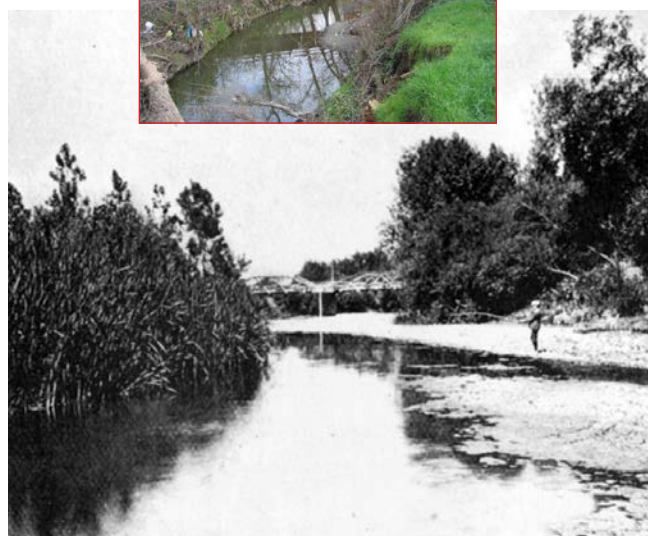
FIGURE III-11. PHOTOGRAPHS OF COYOTE CREEK BETWEEN THE OAKLAND ROAD AND SOUTHERN PACIFIC RAILROAD CROSSINGS, 1896. This pair of photographs shows the dense and tall riparian forest canopy along this relatively narrow channel reach. Even the narrow reaches had significant unvegetated gravel bars and pools. Such a clear view is no longer possible as vegetation has now encroached substantially into the former channel, with some apparent incision (see inset) (Shortridge 1896: 20,174, courtesy History San José).

In the Mid-Coyote reach, Coyote Creek shifted to a mostly wide, entrenched system with broad flood-prone benches. Wide reaches were interspersed with narrow reaches (FIGURE III-10). This pattern of constriction and expansion significantly shaped transportation patterns on the east side of San Jose, with important crossings associated with the narrow reaches between the S. Pacific Railroad and Oakland

Road (FIGURE III-11). and between Julian Street and San Antonio Street. Agriculture and garbage dumps encroached upon the stream benches, then commercial development and other uses – but little housing. Many former dumps are now city parks (FIGURE III-12).

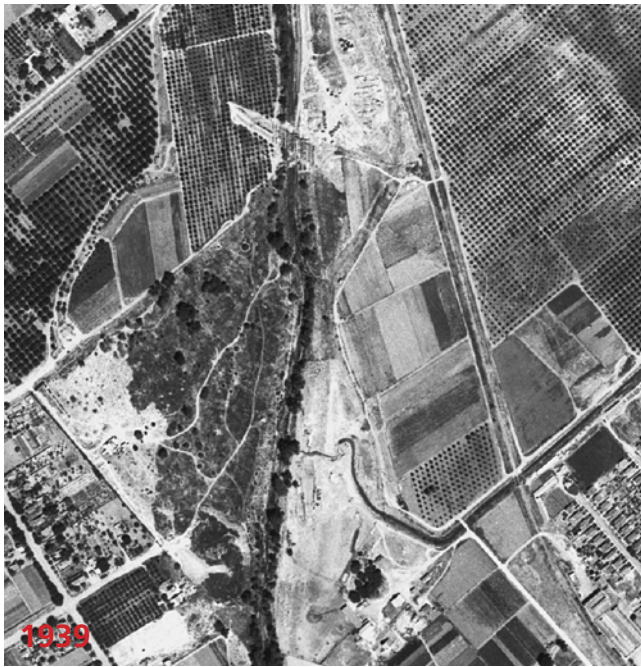
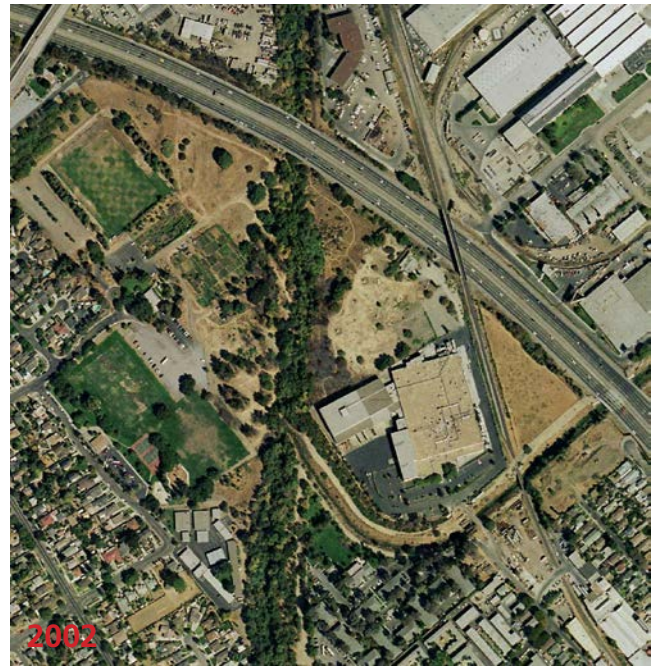
FIGURE III-12. STREAM BENCHES BECOME PARKS. In the contemporary image (upper right; Imagery Copyright 2005 AirPhotoUSA, LLC, All Rights Reserved), Watson Park is located immediately left of the Coyote Creek riparian forest. Highway 101 crosses diagonally. Each park occupies large lateral stream benches still subject to flooding. In 1939 (upper left; AAA 1939), agriculture and landfill operations take place in the future location of Watson Park. The location of the outer channel banks/valley floor is evident as hatch marks in the 1876 map (lower left; Thompson and West 1876, courtesy David Rumsey, Cartography Associates), breaks in land use in the 1939 image, and contours in the USGS (San Jose East & West 7.5 min 1980) quadrangle (lower right).

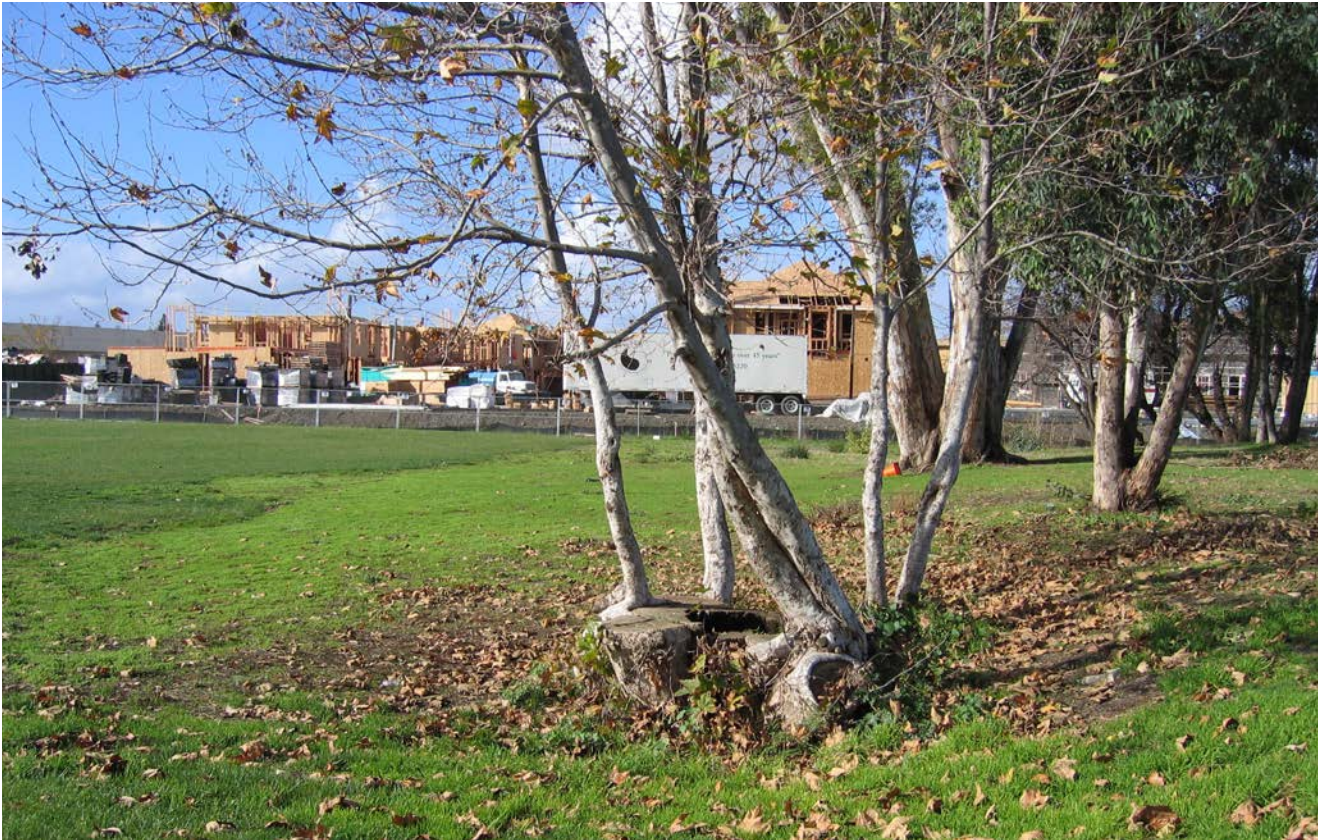
FIGURE III-13. RESIDUAL ELEMENTS OF THE FORMER LOWER PENITENCIA CREEK CHANNEL. Low area through center of photograph indicates historical channel location. A large, historic sycamore has resprouted.

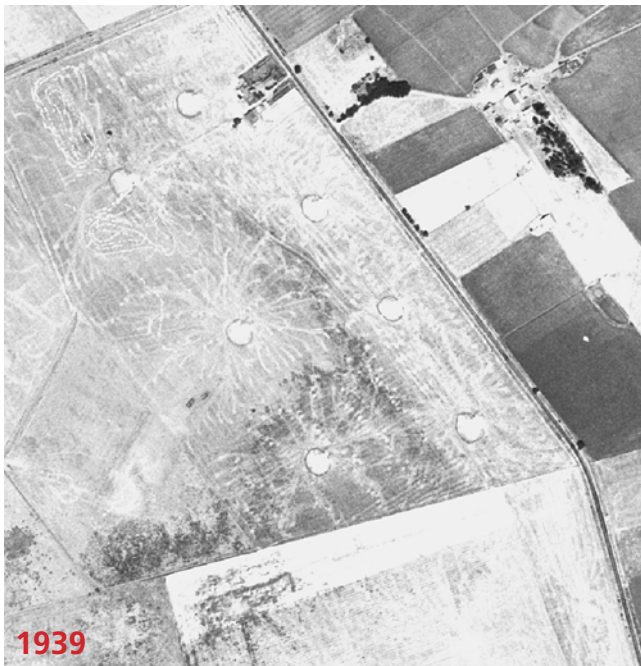
FIGURE III-15. LOCATION OF LAGUNA SOCAYRE AND LAKE CUNNINGHAM IN 1939 (LEFT) AND 2002 (RIGHT). Cow paths mark the unfarmed area of the historical Laguna Socayre in 1939 (AAA 1939). Part of the area has now been excavated to create Lake Cunningham, a storm-water detention basin. Some elements of alkali meadow persist in the fields along the north edge of the lake. A blue circle indicates the location of **FIGURE III-16** and red circles locate the images in **FIGURE III-17** (2002 Imagery Copyright 2005 AirPhotoUSA, LLC, All Rights Reserved).

These conditions limited agricultural development such that grazing, not orchards, was dominant in the 1930s (**FIGURE III-15**). As a result, a number of large, institutional land uses currently predominate here, including Reid Hillview Airport, Lake Cunningham, and Pleasant Hills Golf Course — and some wetland features are still apparent. Low areas of the golf course, coinciding with the historical Laguna boundary, form ponds in the winter (**FIGURE III-16**). Saltgrass meadows with seasonal ponds coexist with grassy fields on the north edge of Lake Cunningham at the exact site of Day’s alkaline description 150 years earlier (**FIGURE III-17**).

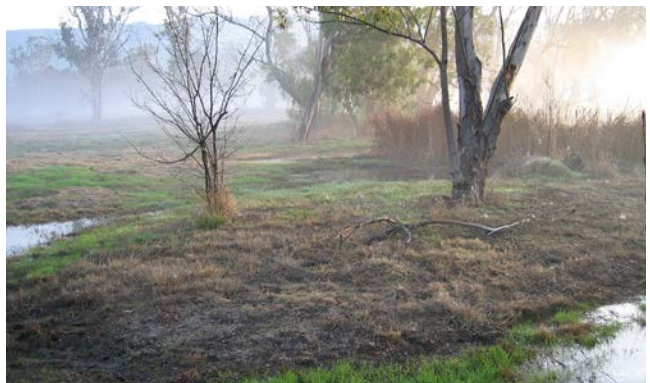
FIGURE III-16. TEMPORARY PONDING AT HISTORICAL LAGUNA SOCAYRE. Surface water and wetland vegetation can be identified in scattered places, corresponding to the former wetland area.

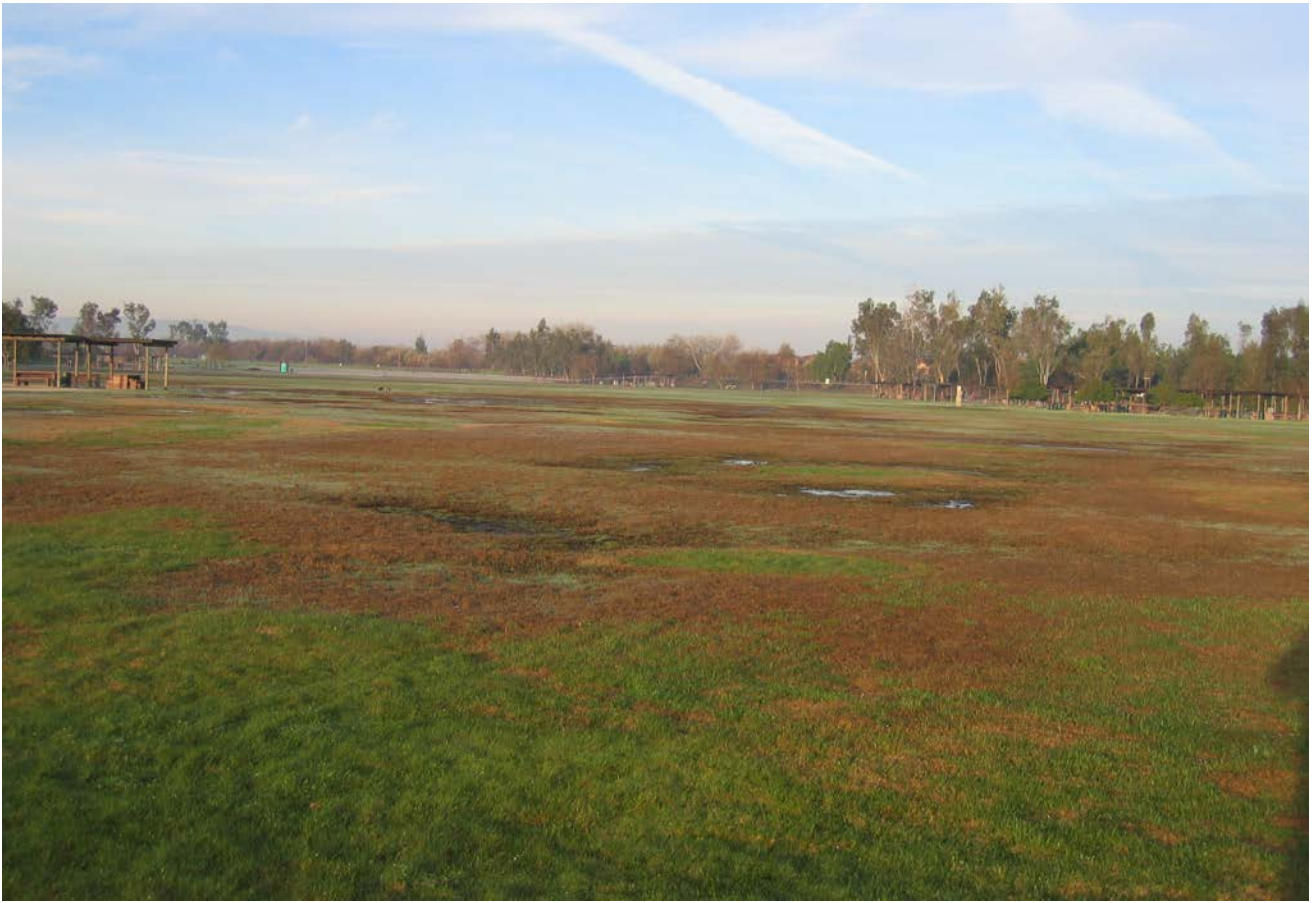
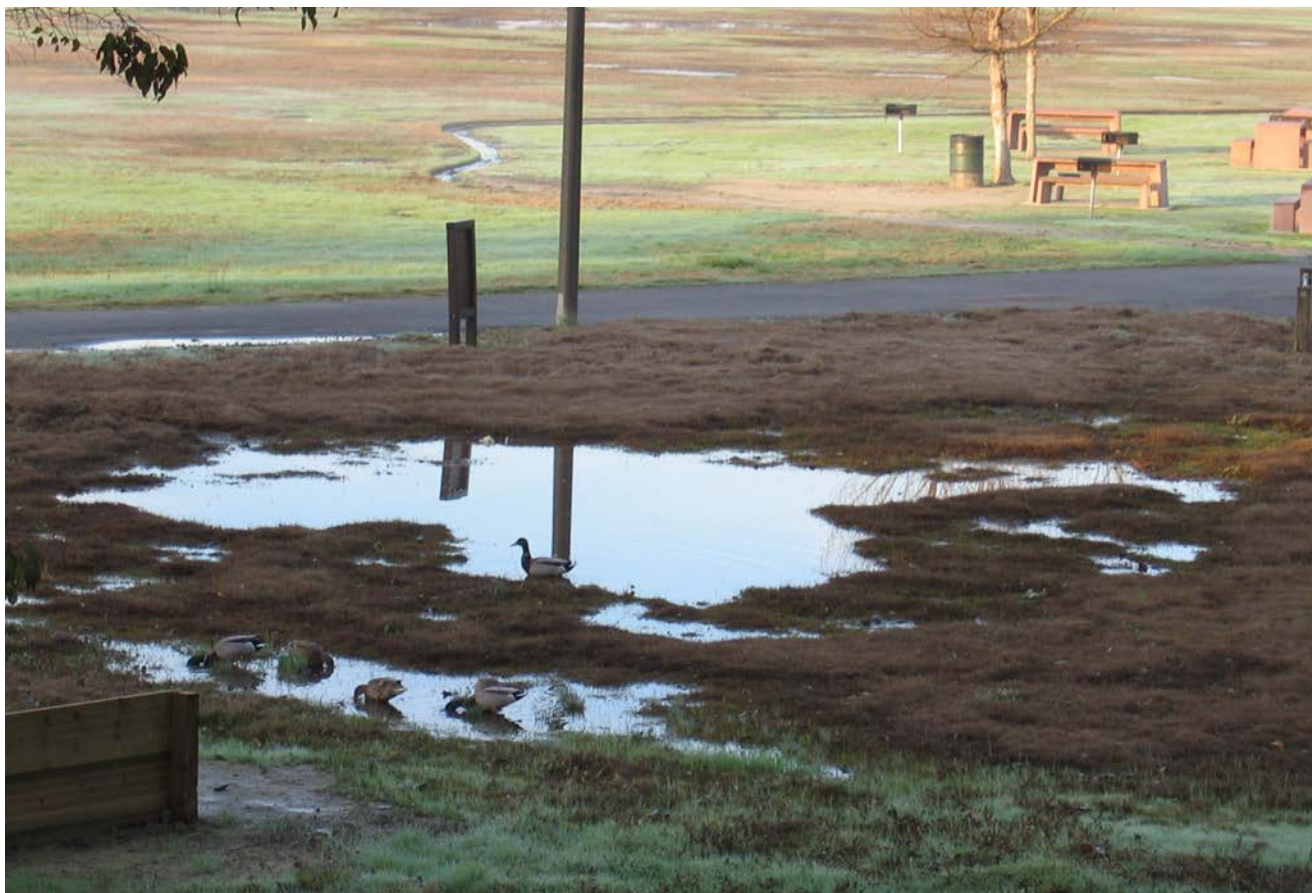
FIGURE III-17. SALTGRASS-ALKALI MEADOW AT LAKE CUNNINGHAM REGIONAL PARK. Reddish-brown areas are predominantly *Distichlis* patches. Scattered ponds form during rainfall events. The lower image shows a well-defined panne with mud bottom and forage for dabbling ducks; other ponds are more temporary.

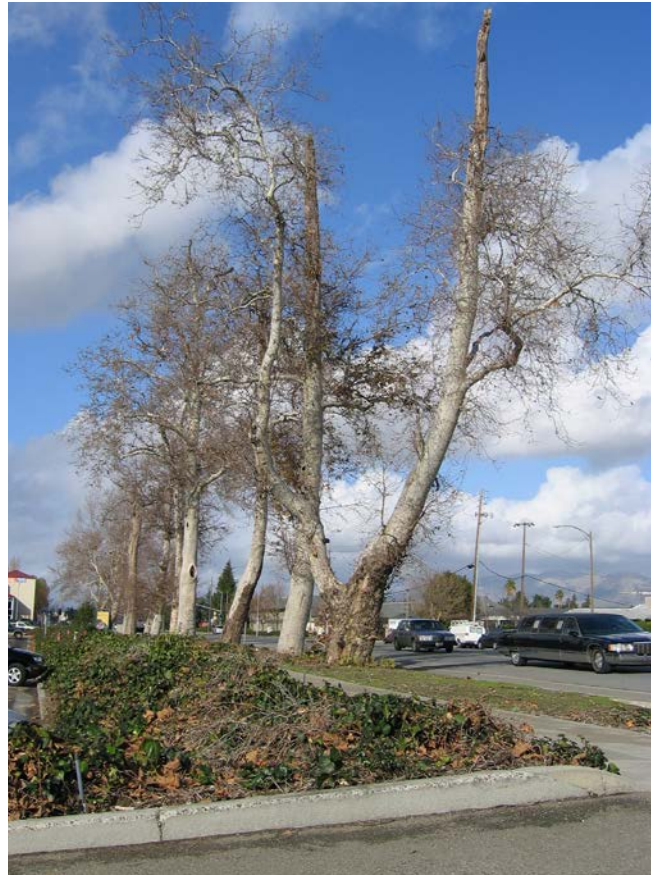
FIGURE III-18. CALIFORNIA SYCAMORES ALONG OAKLAND ROAD. Recurved branching pattern and distinctive leaves indicate that these street trees are the native *Platanus racemosa*, rather than the more common Western Planetree. There appear to be other California sycamores in the neighborhood, potentially descending from the historical grove.

Along Oakland Road, within the estimated boundary of the sycamore grove (Medium Location Certainty, 150 m), an unusual row of California Sycamore trees may be descendent of the original grove (**FIGURE III-18**).

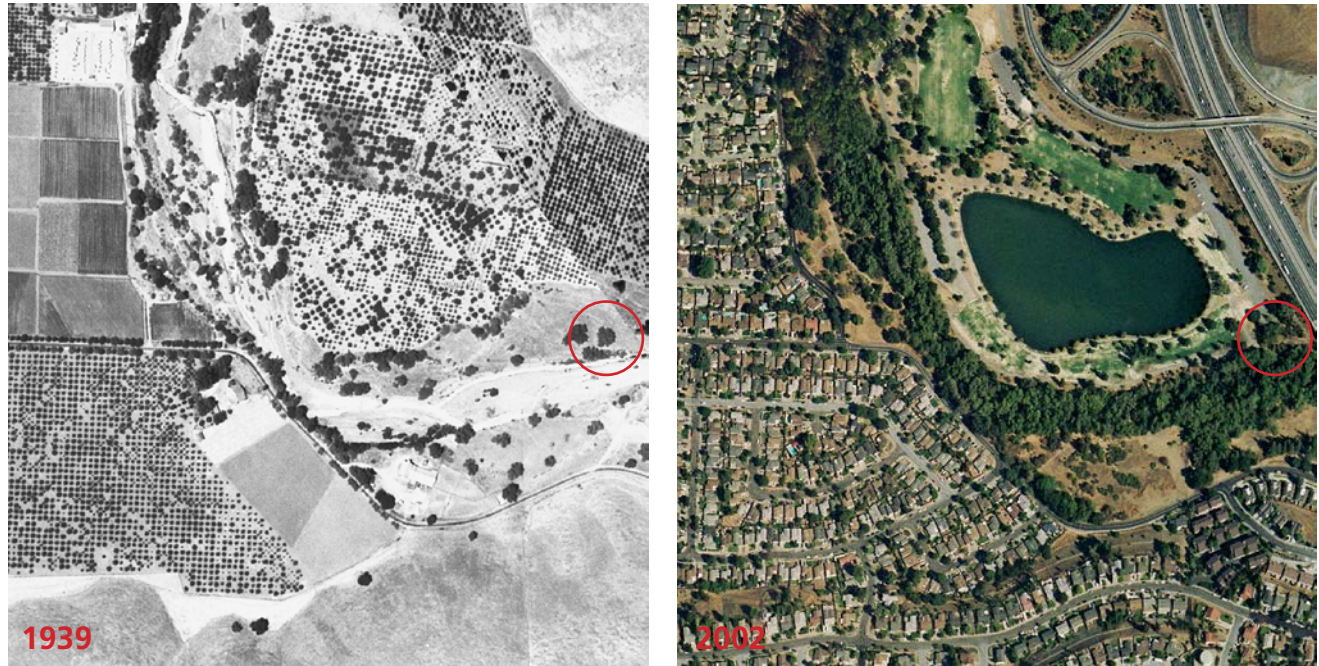
FIGURE III-20. COYOTE CREEK AT COTTONWOOD LAKE IN 1939 (LEFT) AND 2002 (RIGHT). In the earlier image, we can see a wide main channel with little vegetation except for patches of riparian scrub. Larger trees are located on the adjacent stream benches and, in places, there are linear strands of riparian forest along the outer banks of the channel area. The contemporary image shows a more dense and continuous riparian forest. The sycamore shown in **FIGURE III-21** is indicated by a red circle in both images (AAA 1939; 2002 Imagery Copyright 2005 AirPhotoUSA, LLC, All Rights Reserved).
