PART III //

HISTORICAL LANDSCAPE CONDITIONS AT THE LOCAL SCALE

Part III examines conditions prior to Euro-American modification in more detail, focusing on channel morphology, wetland types, plant communities and their controlling physical processes. We also describe the evidence supporting these interpretations.

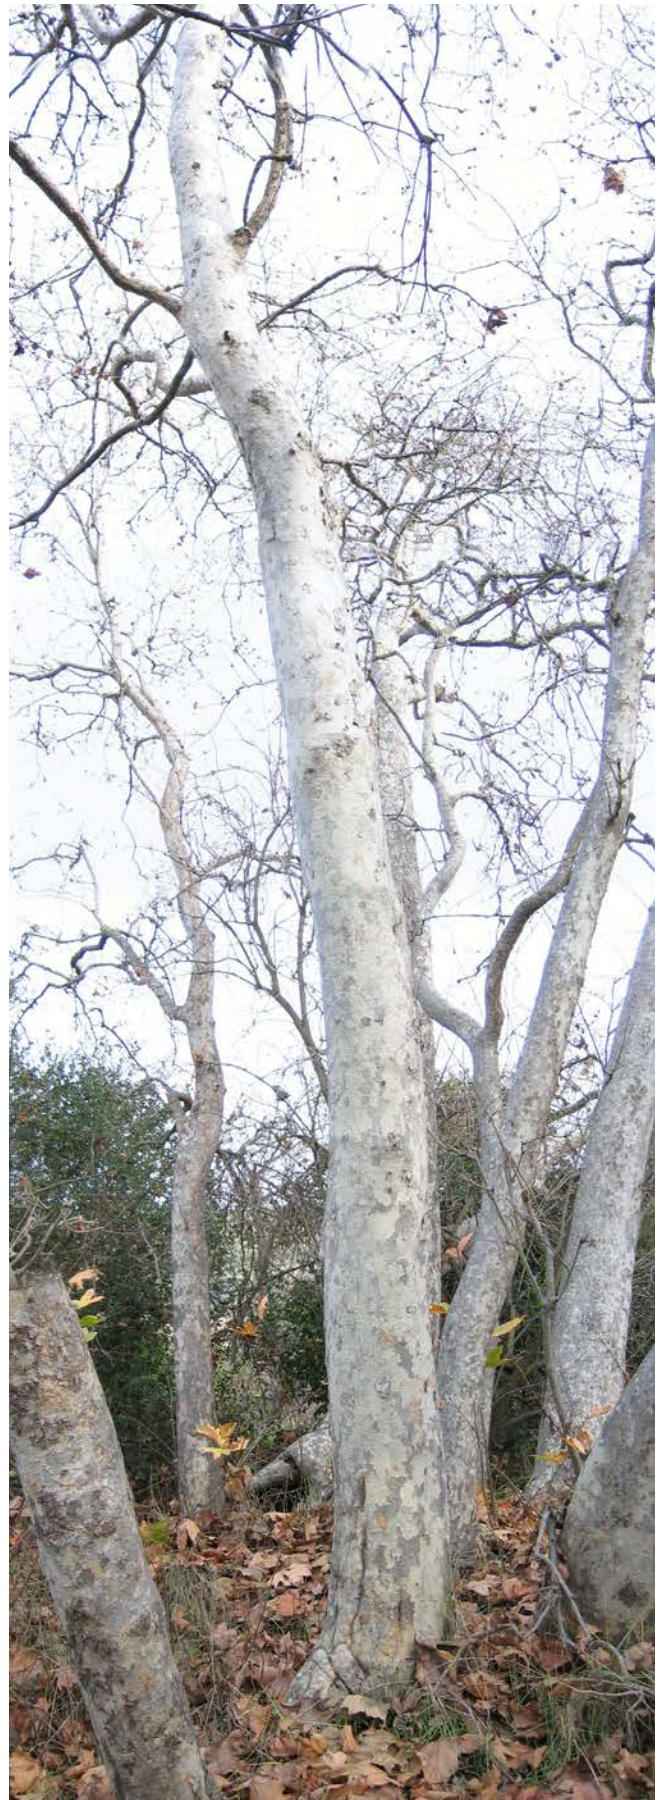
FIGURE III-21. SYCAMORE CIRCLE AT COTTONWOOD LAKE. These trees are sprouts from a giant stump in the center, potentially one of the "large sycamores" reported by Wallace and Healy in 1858-1863 (see page II-42).

Coyote Creek displayed a braided channel pattern throughout this reach. Scattered sycamore trees occupied islands, bars, and benches in the broad channel reaches. Linear strands of riparian forest were occasional on the outer banks of the channel area. FIGURE III-20 shows this riparian pattern along present-day Cottonwood Lake, where surveyors Wallace and Healy reiterated the wide spacing of sycamore trees in the mid-19th century (see PART II, Riparian Habitat), and a few remnant trees can be found presently (FIGURE III-21). Riparian habitat has shifted to a dense forest dominated by cottonwoods.

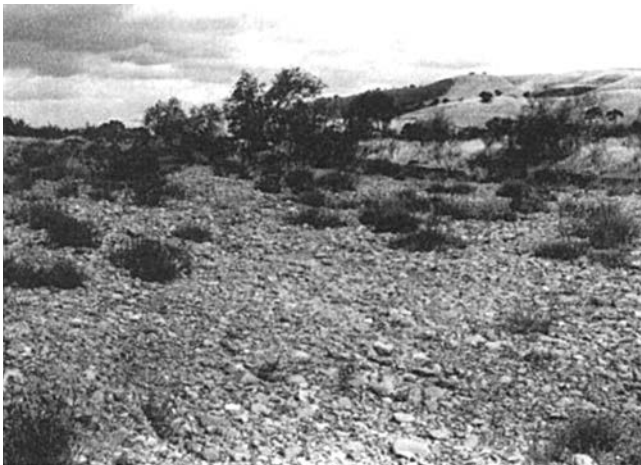
FIGURE III-22. BROAD, GRAVELLY COYOTE CREEK BED IMMEDIATELY DOWNSTREAM OF COYOTE NARROWS, CIRCA 1930. Vegetation is described in **TABLE II-2** (Pickwell and Smith 1938, courtesy Cooper Ornithological Society).

The GLO field surveys conducted during the 1850s documented a broad, active channel area recording, for example, that the creek between Tenant Avenue and Coyote Narrows ranges from three to eight chains wide (198-528 feet), corresponding closely with our mapped channel area. Photographs taken in the early 1930s as part of a study of Lesser Nighthawks show channel morphology and vegetation immediately downstream of Coyote Narrows at the present-day location of the Coyote Percolation Ponds (**FIGURE III-22**). Close-ups of nighthawk nests show a wide range of poorly sorted sediment sizes, indicative of braided channel character (**FIGURE III-23**). Conversion here has been dramatic, with the creek now flowing through a large, impounded water body.

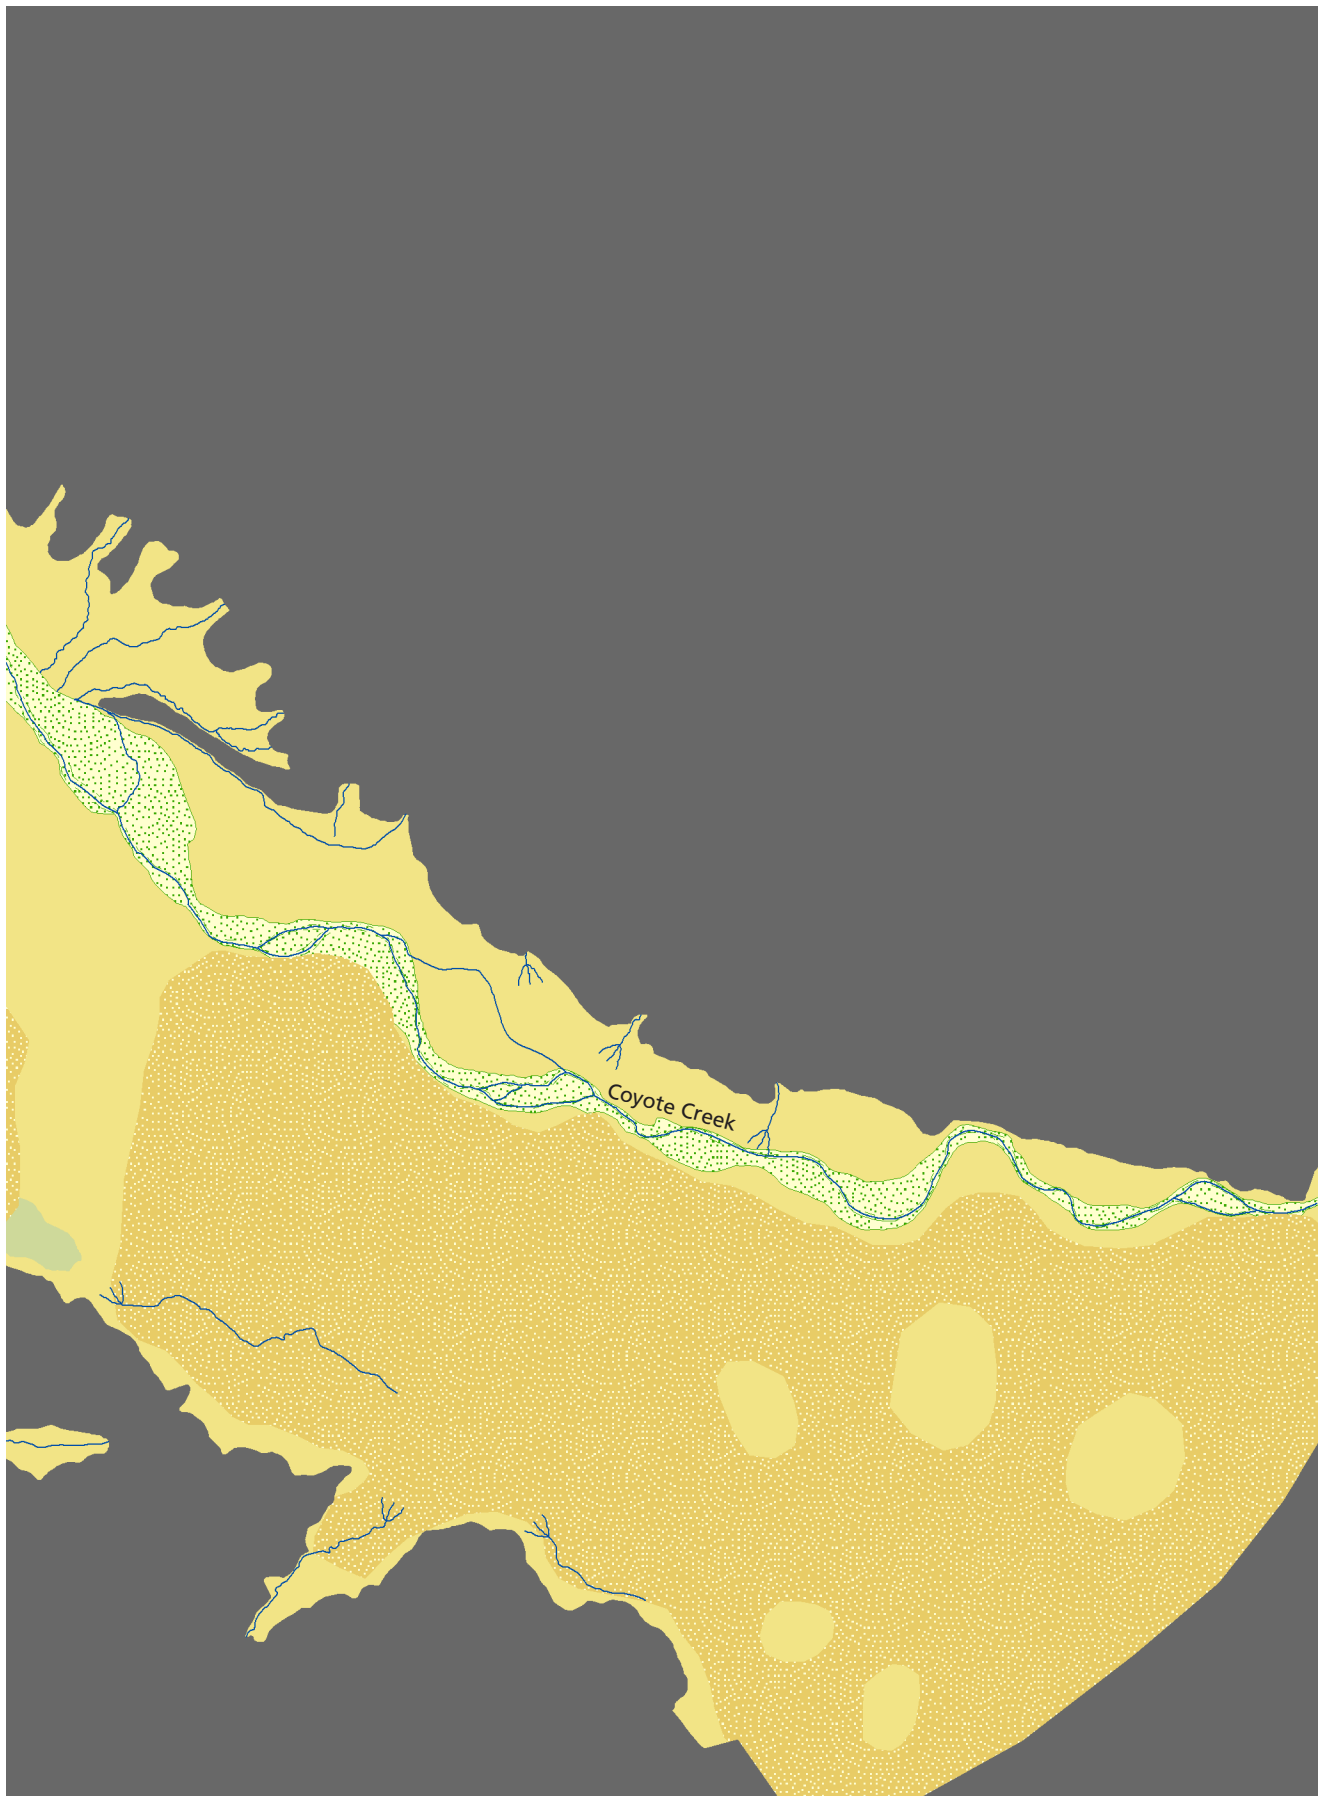
MAP 4B-CA.1800. LANDSCAPE FEATURES DURING INITIAL EURO-AMERICAN SETTLEMENT, CIRCA 1769-1850. Certainty level varies among features; valley oak savanna is a preliminary estimate. More information is available in the project GIS (scale 1:40,000; 1"~3300'; 1 square inch ~250 acres). See inside front cover for map legend.

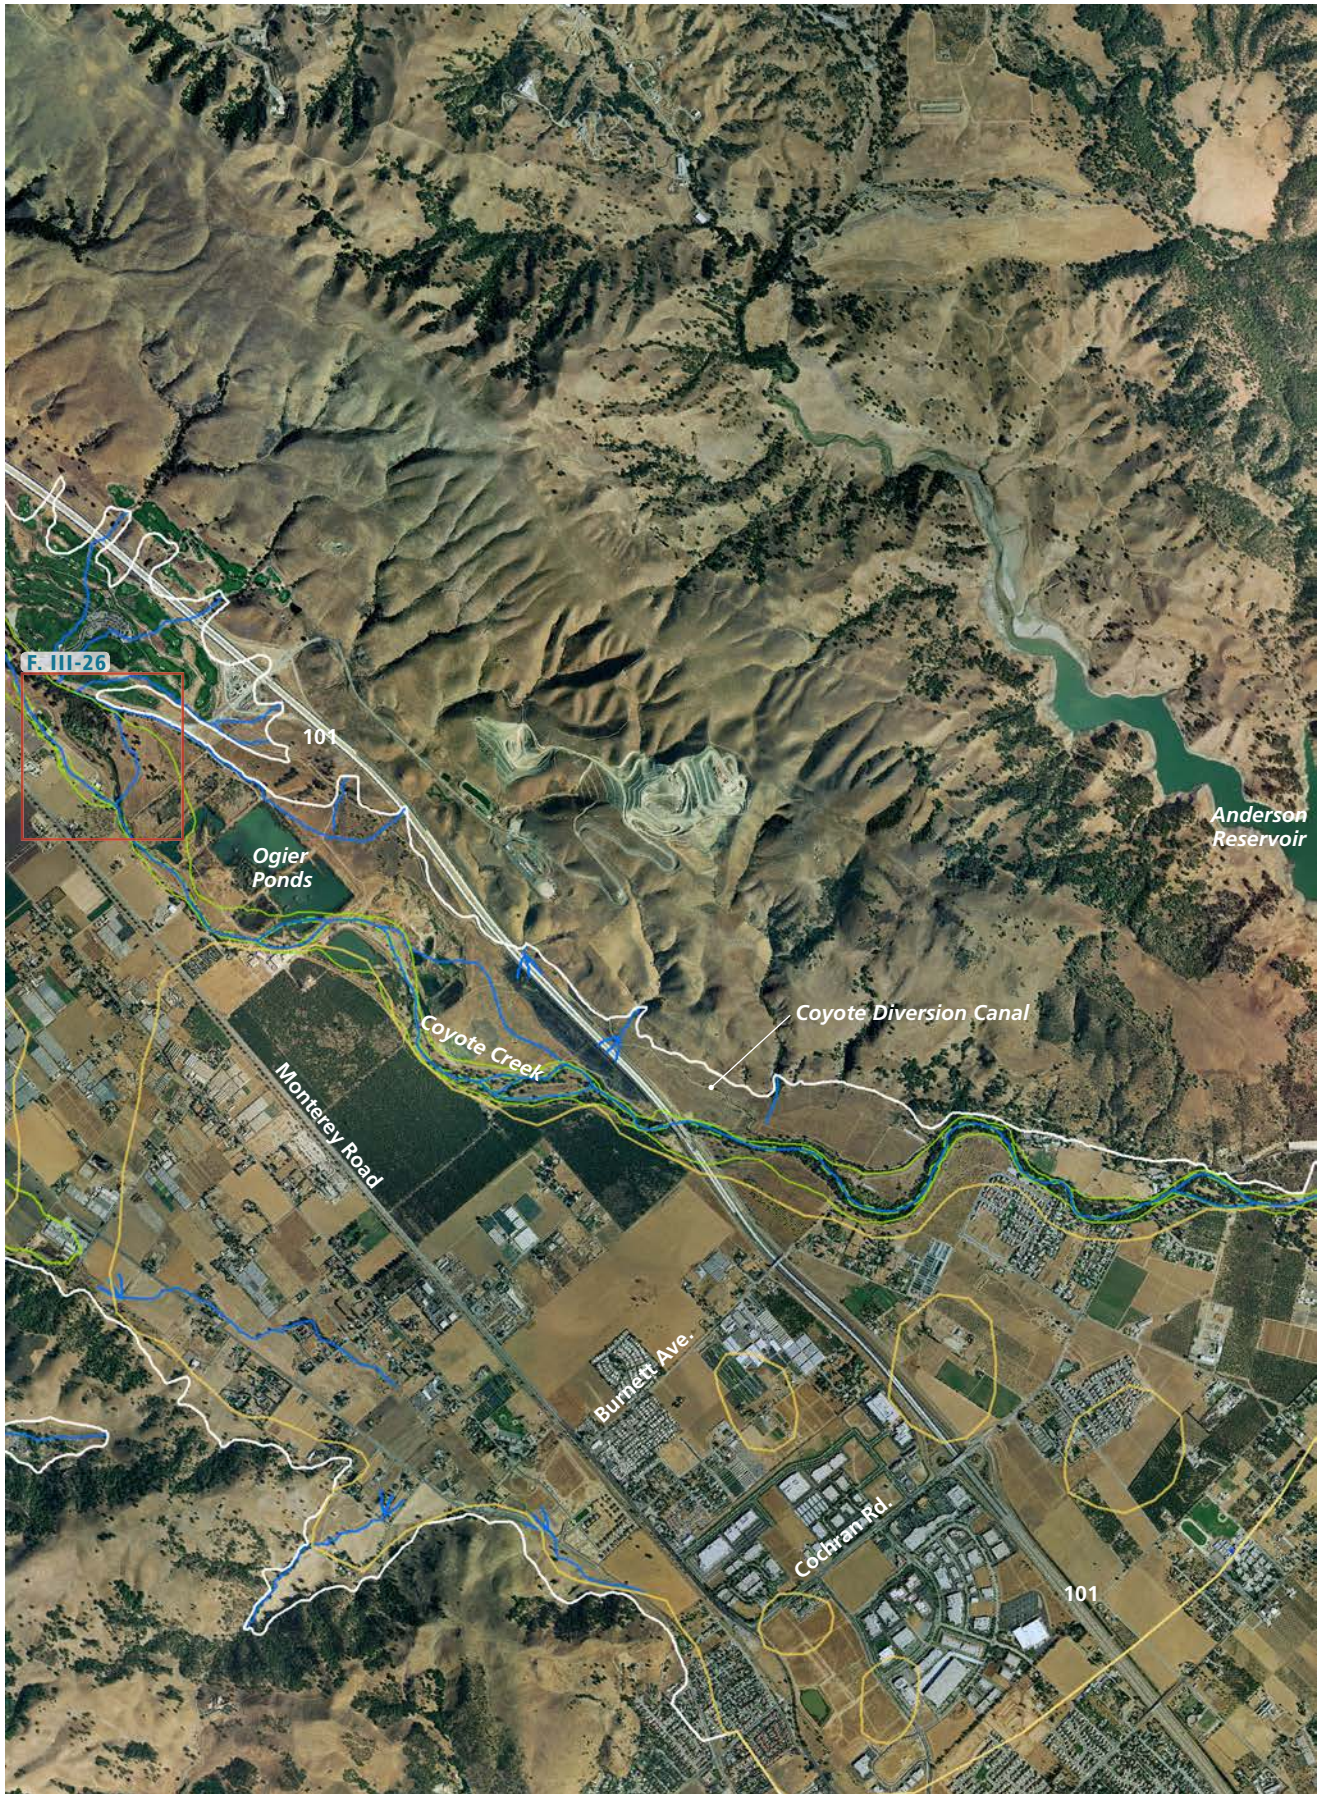
MAP 4B-2002. MODERN AERIAL IMAGERY, WITH HISTORICAL LANDSCAPE FEATURES OVERLAY. Historical fluvial features in blue; other features, green; project boundary, white (scale 1:40,000; 1"~3300'; 1 square inch ~250 acres; Imagery Copyright 2005 AirPhotoUSA, LLC, All Rights Reserved).

Coyote Valley is shaped by the cone of alluvial sediment spreading downward from the canyon mouth, at the present-day site of Anderson Dam. Currently, Coyote Creek flows to the north, but in previous ages it has flowed south to Monterey Bay. The subtle watershed divide here, crossed in the vicinity of Morgan Hill, is formed purely by the alluvial topography.

A vast valley oak savanna occupied much of Coyote Valley, with small and large “oak openings” (FIGURE III-24). Coyote Creek maintained a “wide, gravelly bed” that excluded agriculture from a broad zone (Broek 1932). Steep creeks approached the creek from the hills immediately east of the channel, likely contributing to a high sediment load. On the west side of the Valley, the streams, including Fisher Creek, were discontinuous.

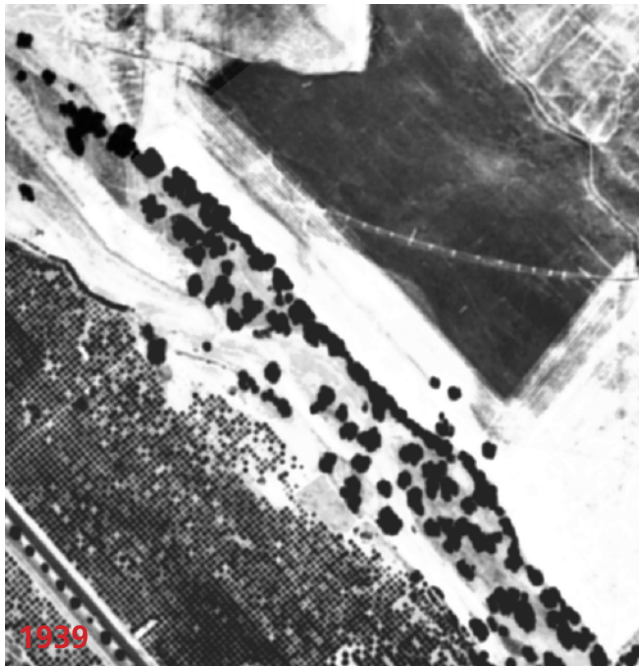
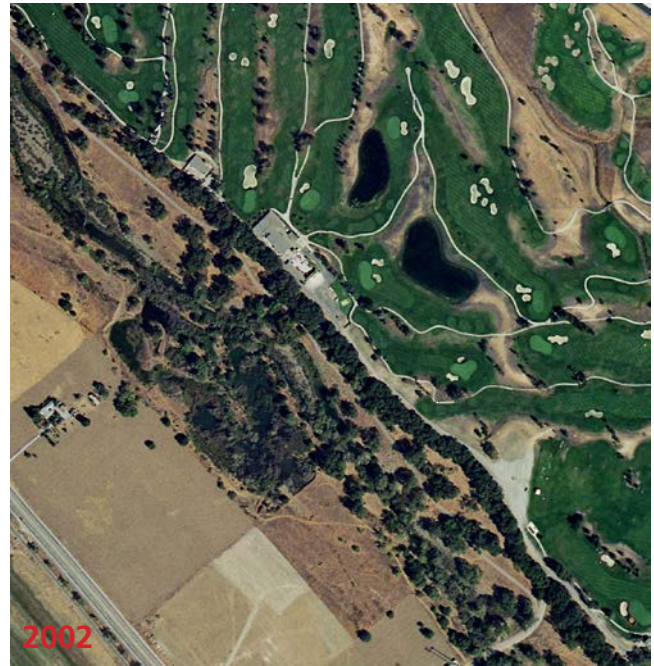
FIGURE III-25. COYOTE CREEK AT THE COYOTE CREEK GOLF CLUB IN 1939 (LEFT) AND 2002 (RIGHT). The 1939 (AAA 1939) image shows several of the common characteristics of the braided Coyote Creek channel historically found from approximately Tully Road to Ogier Ponds/Highway 101 crossing. These include riparian woodland composed of large widely spaced trees; substantial unvegetated, scoured areas; and strands of mixed riparian forest following one of the outer banks. These elements are relatively intact presently, as can be seen in the contemporary image (2002 Imagery Copyright 2005 AirPhotoUSA, LLC, All Rights Reserved).

In this reach, Coyote Creek presently exhibits some of its most un-modified morphology and riparian habitat. Examples of sycamore alluvial woodland and open riparian scrub can be found upstream and downstream of Ogier Ponds, representing significant residual habitats (FIGURES III-25 and III-26, see also FIGURE IV-35).

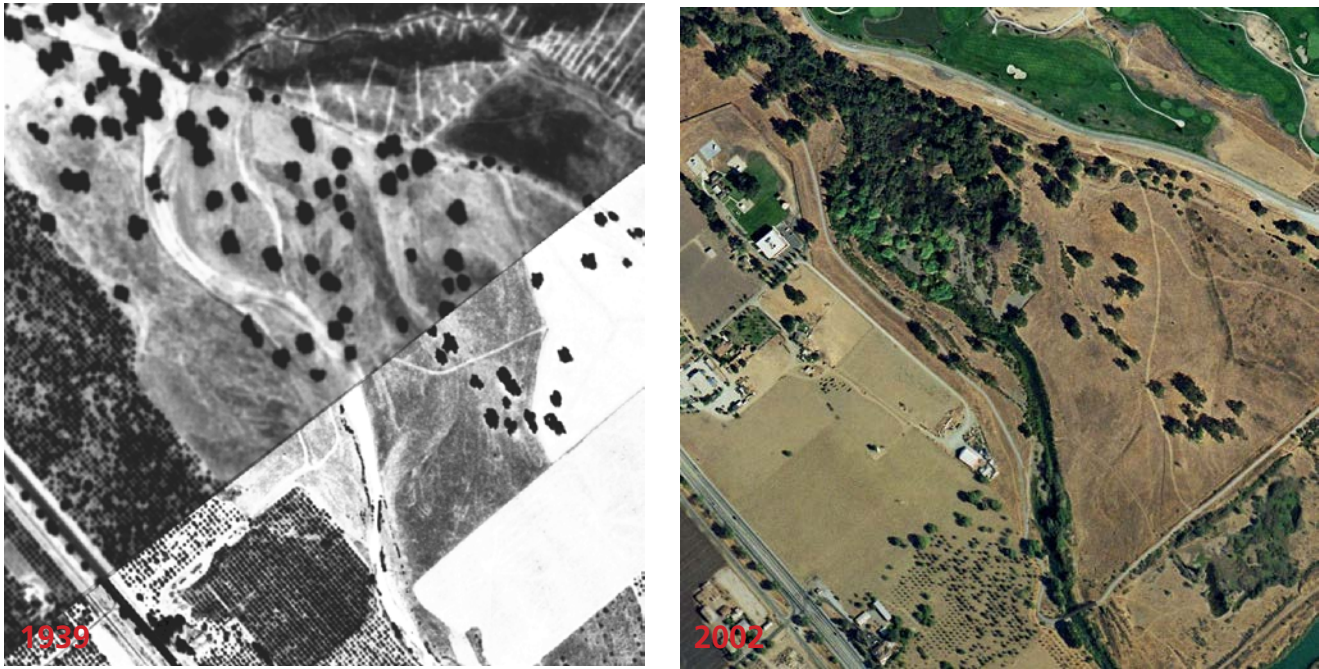
FIGURE III-26. COYOTE CREEK IMMEDIATELY DOWNSTREAM OF OGIER PONDS IN 1939 (LEFT) AND 2002 (RIGHT). The open riparian and channel pattern visible in 1939 (AAA 1939), which closely matched that described by Howe in 1851, has filled in substantially, probably as a result of decreased winter flows and increased summer flows (2002 Imagery Copyright 2005 AirPhotoUSA, LLC, All Rights Reserved).

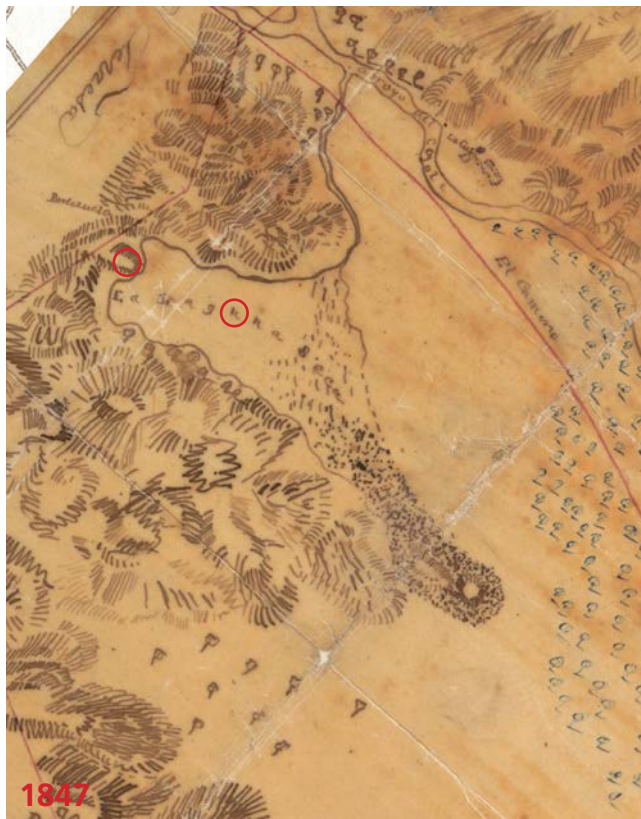
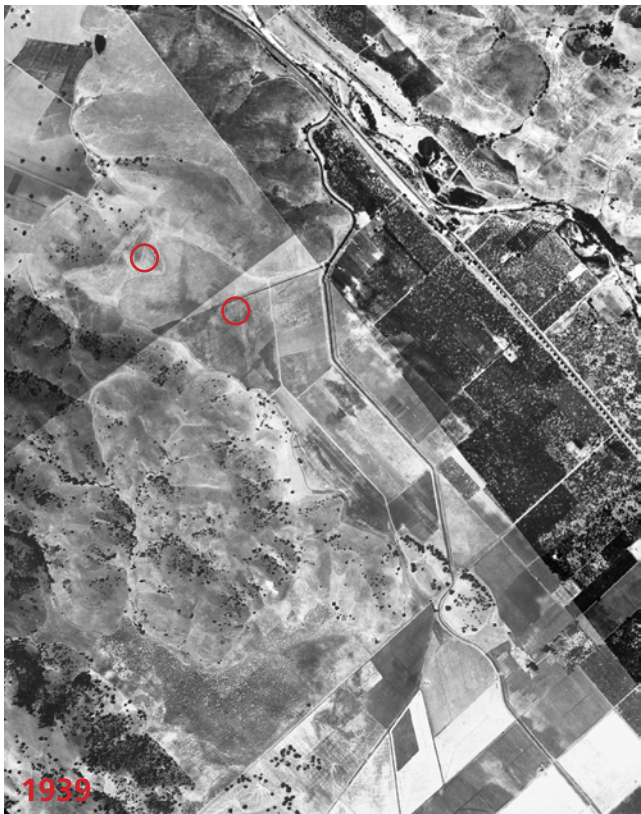
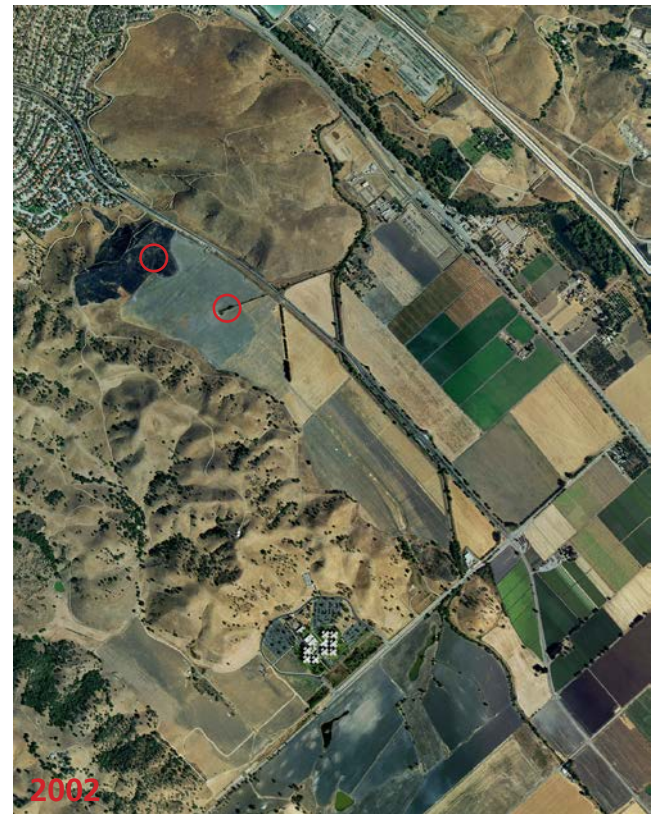
FIGURE III-27. LAGUNA SECA IN 1847, 1915-16, 1939, AND 2002. The 1847 Rancho Laguna Seca *diseño*, by the well-respected surveyor Chester Smith Lyman (e.g. Arbuckle 1986:56), shows perennial wetlands and an open water area, with valley oaks located some distance to the east and south. The outlet channel, probably an extension of Alvirez’s canal, has not changed shape much over time, but has received an increasingly greater drainage network. Mottled soil patterns (1939, lower left; AAA 1939) and less agricultural diversification (2002, lower right; Imagery Copyright 2005 AirPhotoUSA, LLC, All Rights Reserved) mark the Laguna site after the 1916-17 reclamation. Approximate locations of the following panoramas are indicated with red circles. Lyman 1847, courtesy The Bancroft Library, UC Berkeley; USGS 1919 and 1940 courtesy Santa Clara Valley Water District.

Laguna Seca provided an important natural water source for waterfowl, amphibians, and local human culture. Since Coyote Creek was seasonally dry along most of its length, there were few sources of water for summer irrigation upstream of San Jose. Laguna Seca thus provided a rare source of summer water. Accordingly, it was tapped for agriculture unusually early, by the 1830s. Gravity fed irrigation from the Laguna led to an odd scenario.

It appears that the prevailing topography (sloping towards the Laguna) caused Alvarez, the recipient of the Laguna Seca land grant, to construct an irrigation system carrying water around Tulare Hill and north through Coyote Narrows (and alongside Coyote Creek) to the lower lying lands to the north. Unfortunately this crossed what became the traditional boundary between the Laguna Seca and the Santa Teresa land grants, as well as the natural boundary between Coyote and Santa Clara Valley

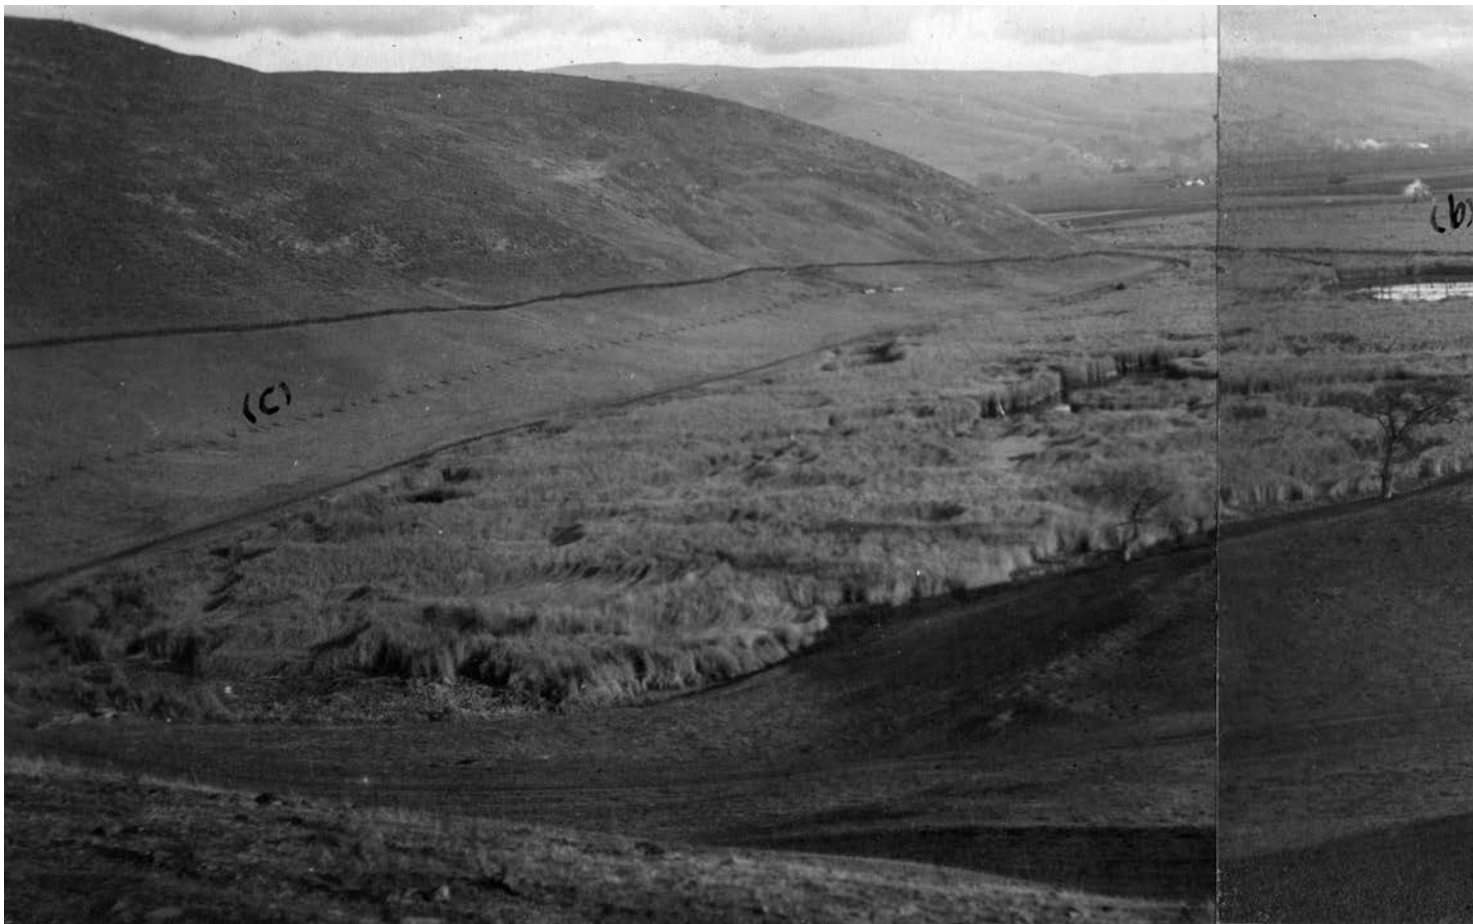
FIGURE III-28. LAGUNA SECA PANORAMA, DECEMBER 28, 1916. This view from the north end of the Laguna shows wetland vegetation and perennial ponds immediately before draining for agriculture. See **FIGURE III-27** for location. SCVWD Vault 1916: 64-65, courtesy the Santa Clara Valley Water District.

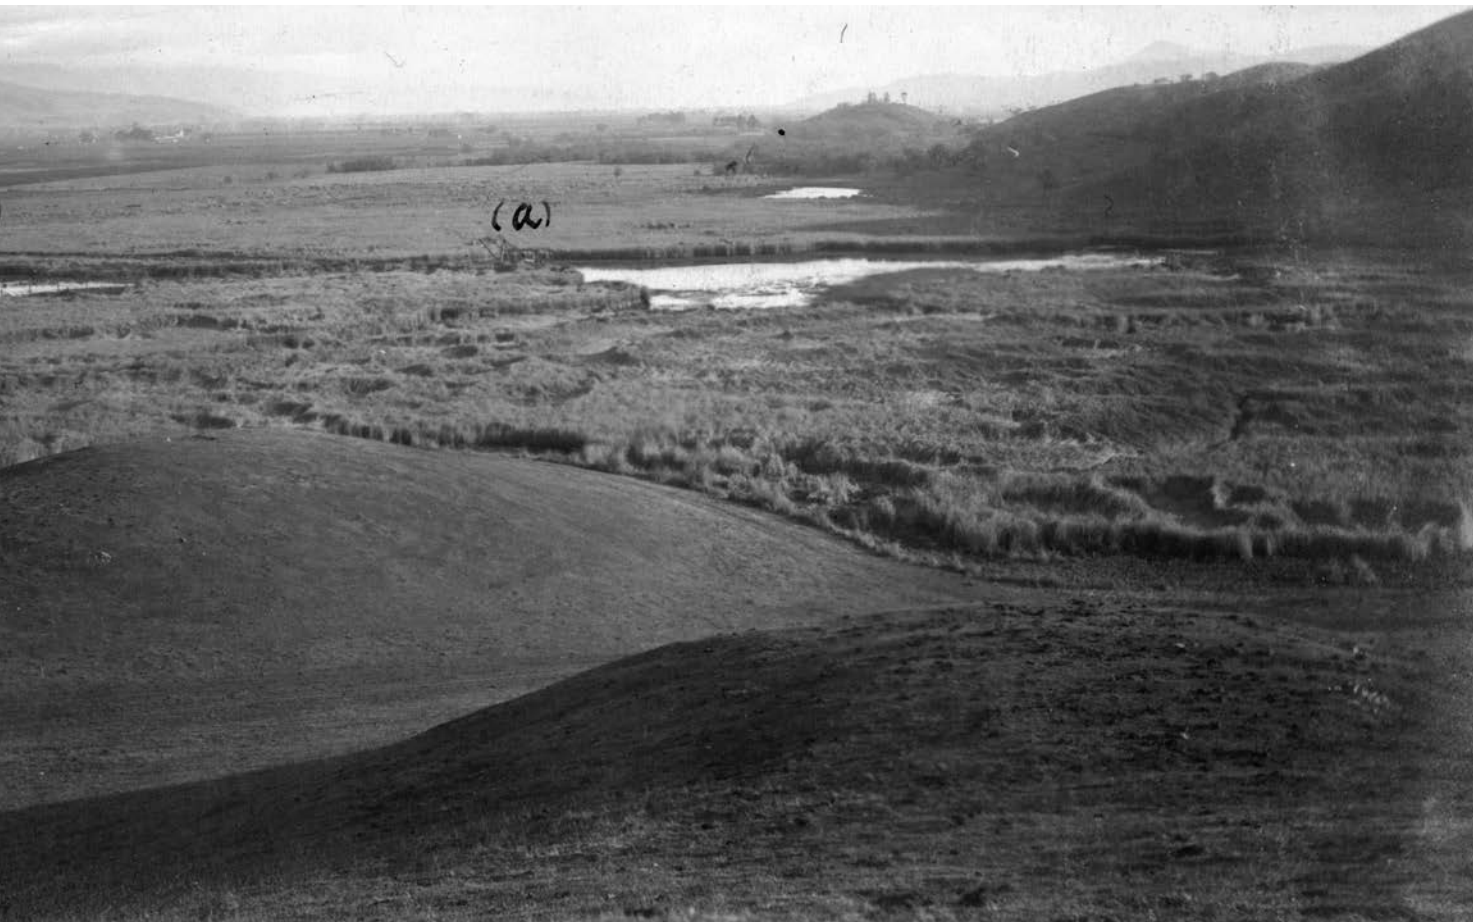
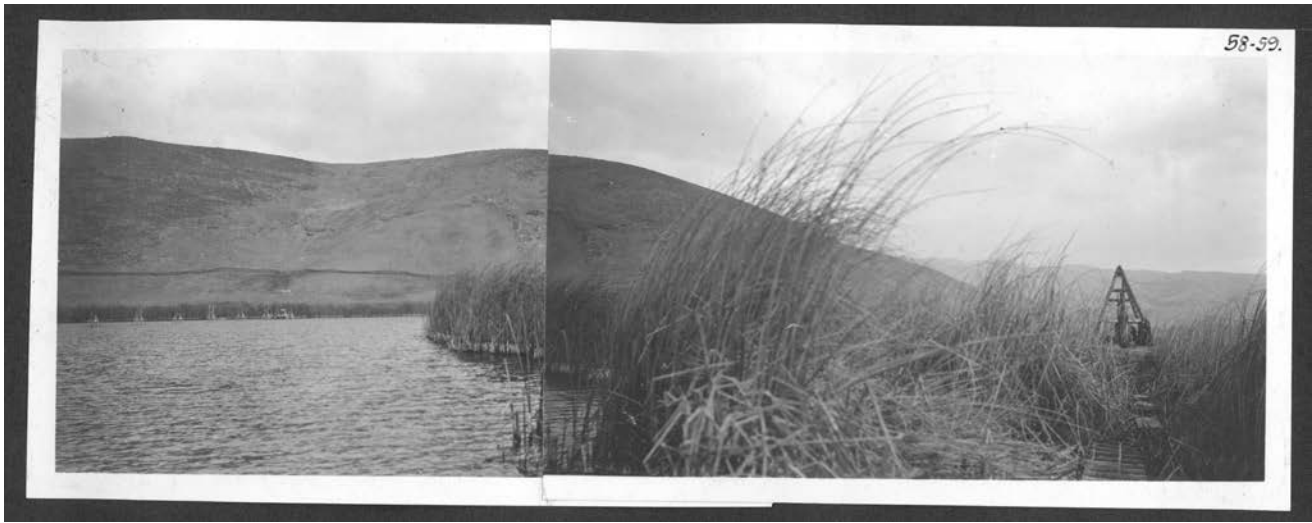
FIGURE III-29. LAGUNA SECA PANORAMA ACROSS A TULE POND, DECEMBER 20, 1916. “View looking westward from Lagoon showing open water (about 4 1/2 ft. deep) with clam-shell working on Ditch advancing through tules (Sta. D’ 22+50) to drain lands.” [Original caption text]. See **FIGURE III-27** for location. SCVWD Vault 1916: 58-59, courtesy the Santa Clara Valley Water District.

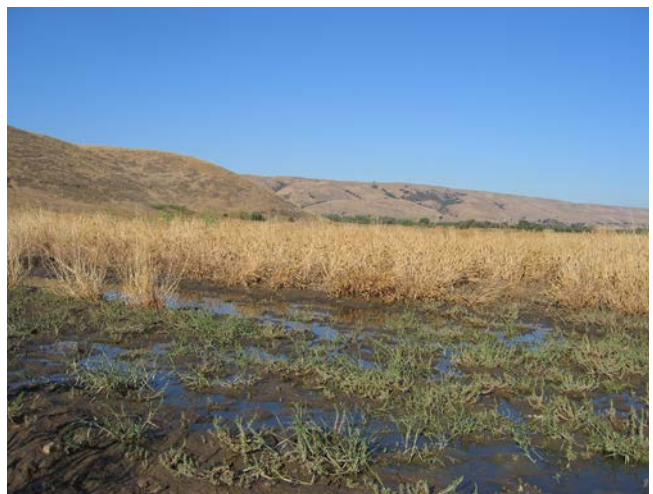
FIGURE III-30. GROUNDWATER SEEPAGE AT NORTH END OF FORMER LAGUNA SECA.

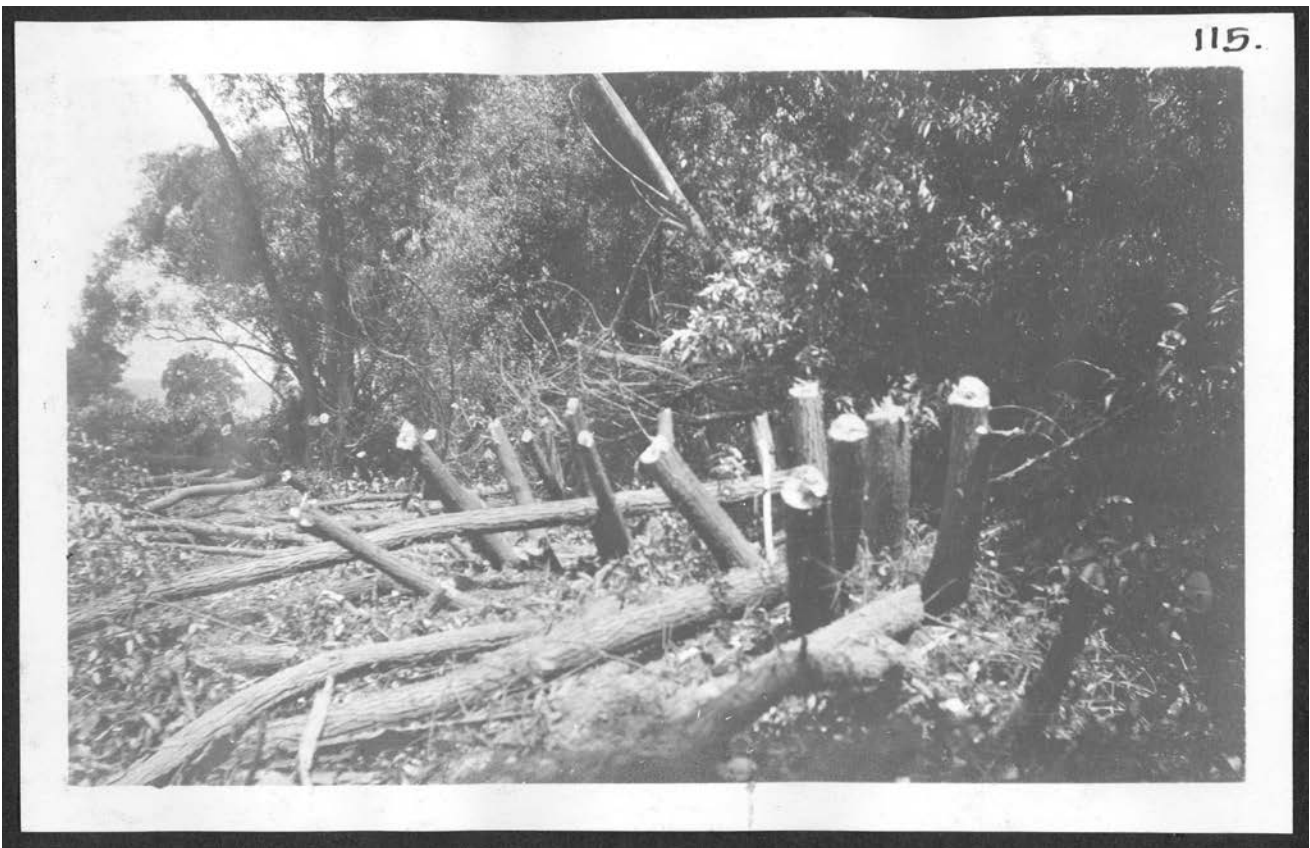
FIGURE III-32. LAGUNA SECA WILLOW GROVE, 1917. This image provides a rare photograph of a Santa Clara Valley *sausal*, or willow grove. SCVWD Vault 1917: 115, courtesy the Santa Clara Valley Water District.
