COYOTE CREEK WATERSHED HISTORICAL ECOLOGY STUDY

HISTORICAL CONDITION, LANDSCAPE CHANGE, AND RESTORATION POTENTIAL

IN THE EASTERN SANTA CLARA VALLEY, CALIFORNIA

Prepared for the
Santa Clara Valley Water District

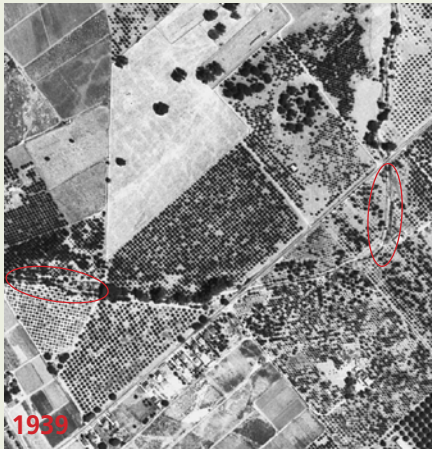
RIPARIAN RECOVERY In this set of aerial photographs, riparian forest along Upper Penitencia Creek – heavily impacted by agriculture in the 1930s – has significantly expanded with the creation of a protective land use buffer.

While riparian forest has been lost along many creeks, a few reaches have shown notable improvement during the past few decades. Some streams have incised greatly, while others show almost no change over the past 150 years. We can look to these sites that have beneficial, positive trajectories as contemporary models for watershed protection and recovery.

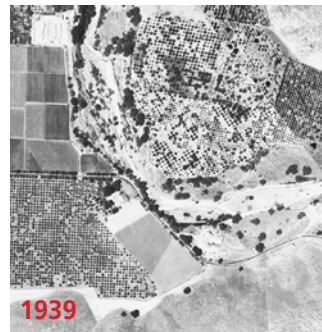
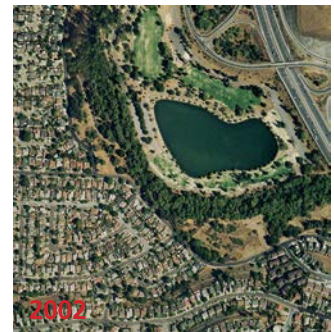
RIPARIAN HABITAT CONVERSION in the vicinity of Cottonwood Lake.

Since the construction of Coyote Dam in 1936, peak flows from most of the upper watershed have been reduced, while summer flows have increased. As a result, trees have invaded the active channel, largely eliminating unvegetated bars and open riparian habitat, and converting one riparian habitat type to another. While clearly possessing riparian value, these new habitats should probably be assessed for long-term viability and ecological function.

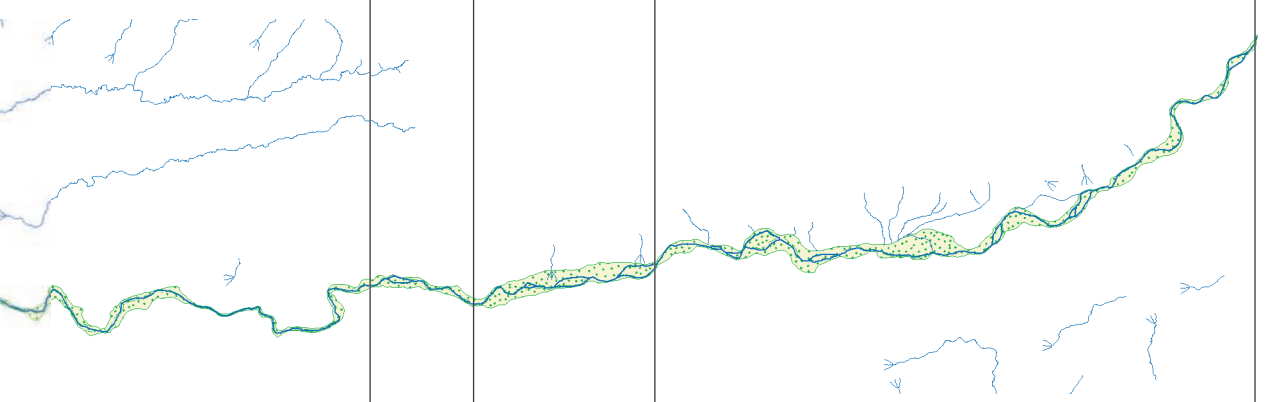
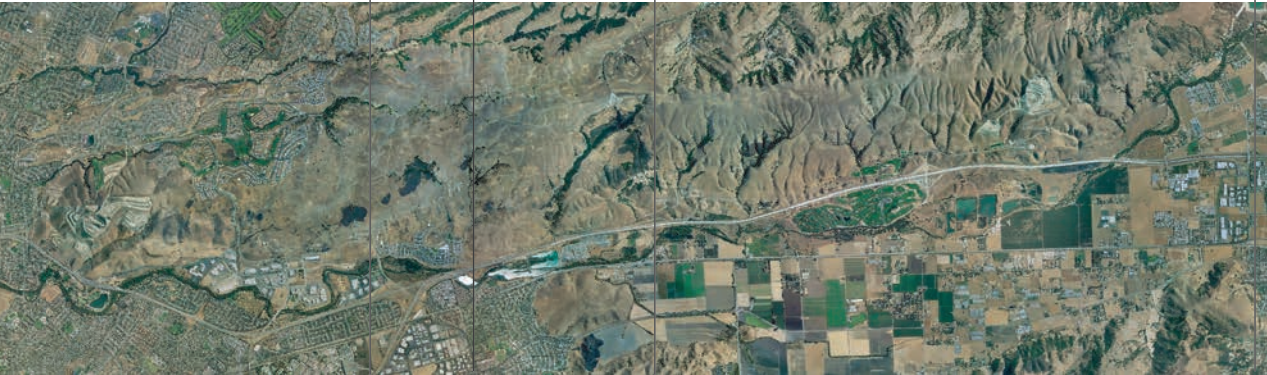
COYOTE CREEK'S HISTORICAL HYDROLOGY, HABITAT, AND MORPHOLOGY

This diagram shows how key attributes of the creek varied naturally by reach. The close relationships between morphology, habitat, and hydrology indicate how physical and ecological processes are interrelated. Transitions between reaches were gradual and varied through time. Cross-sections illustrate reaches based upon historical data (2002 Imagery Copyright 2005 AirPhotoUSA, LLC, All Rights Reserved).

CONCEPTUAL CROSS SECTION (2x vertical exaggeration)

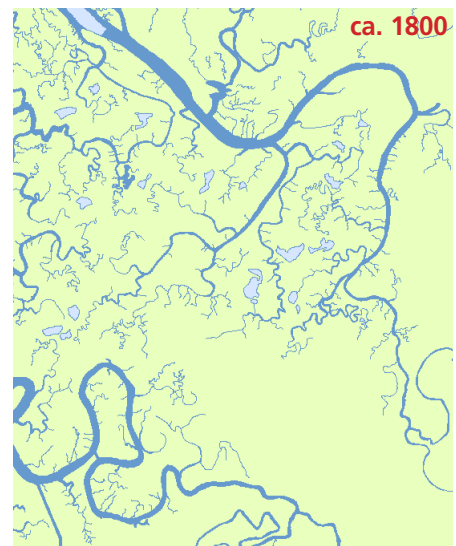
HISTORICAL (CA. 1800) BRACKISH MARSHLAND PATTERNS: tidal sloughs and pannes.

A century ago the tidal and lower reaches of Coyote Creek supported natural fresh and brackish tidal marshlands with a fish assemblage largely similar to those found in the Sacramento-San Joaquin Delta. Treated effluent inputs could be used to reestablish these wetland gradients—now a regionally rare habitat type. Restoration of some of these habitats and their fish populations—a miniature delta—could be of regional significance.

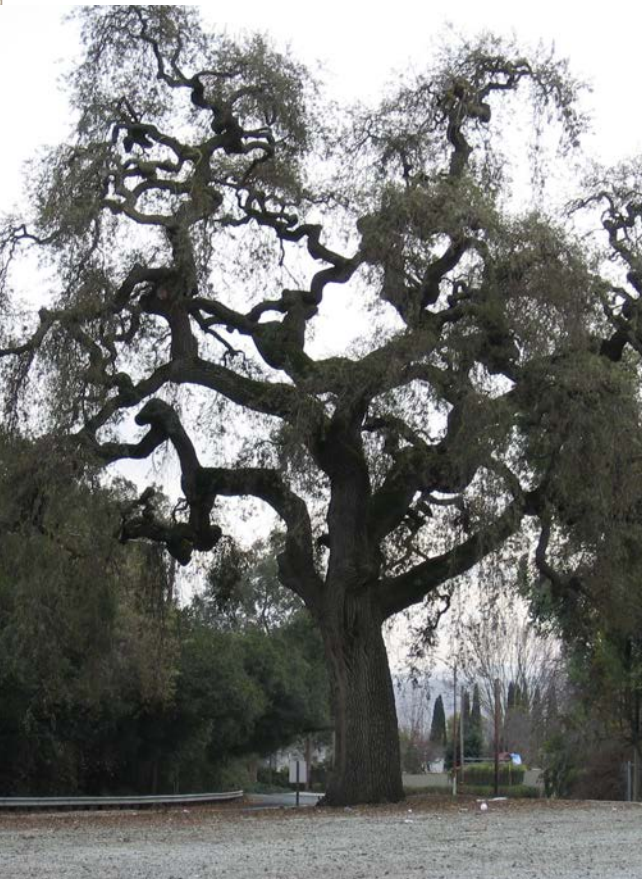
VALLEY OAK ALONG COYOTE ROAD.

Valley oak savanna—grand, widely spaced trees with a grassland understory—was the signature habitat of the Santa Clara Valley. Despite general loss, a surprising number of trees have survived, partly because they have always been recognized for their beauty and shade. But they will need stewardship to survive into the future.

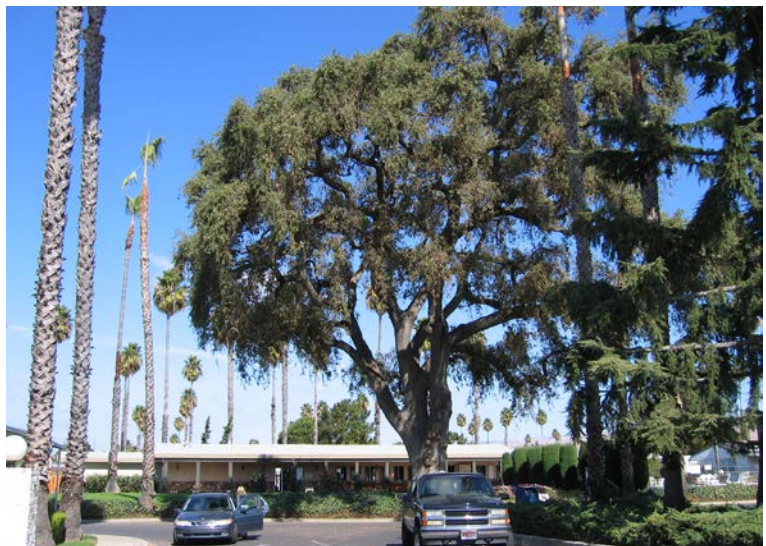
RESIDUAL VALLEY OAK AMONG PALMS, BLOSSOM HILL DRIVE. This grand tree has been preserved as a landscape centerpiece.

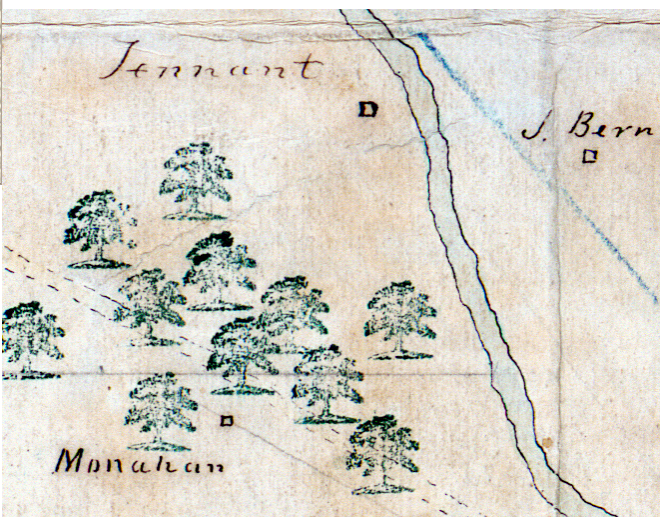
DEPICTION OF VALLEY OAK SAVANNA showing a grove along Monterey Road (Healy, U.S. Dist. Court 1859, courtesy The Bancroft Library, UC Berkeley).

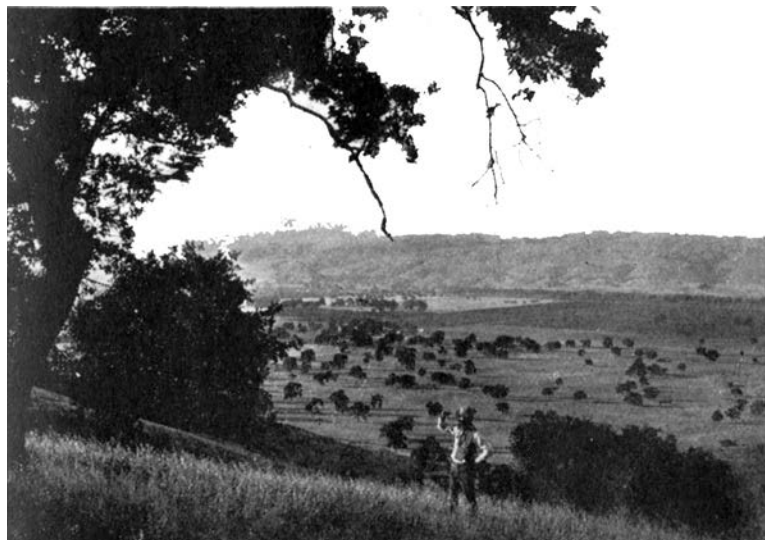
PART OF THE GREAT VALLEY OAK SAVANNA SOUTH OF LAGUNA SECA, CIRCA 1896 (Shortridge 1896, courtesy History San José).

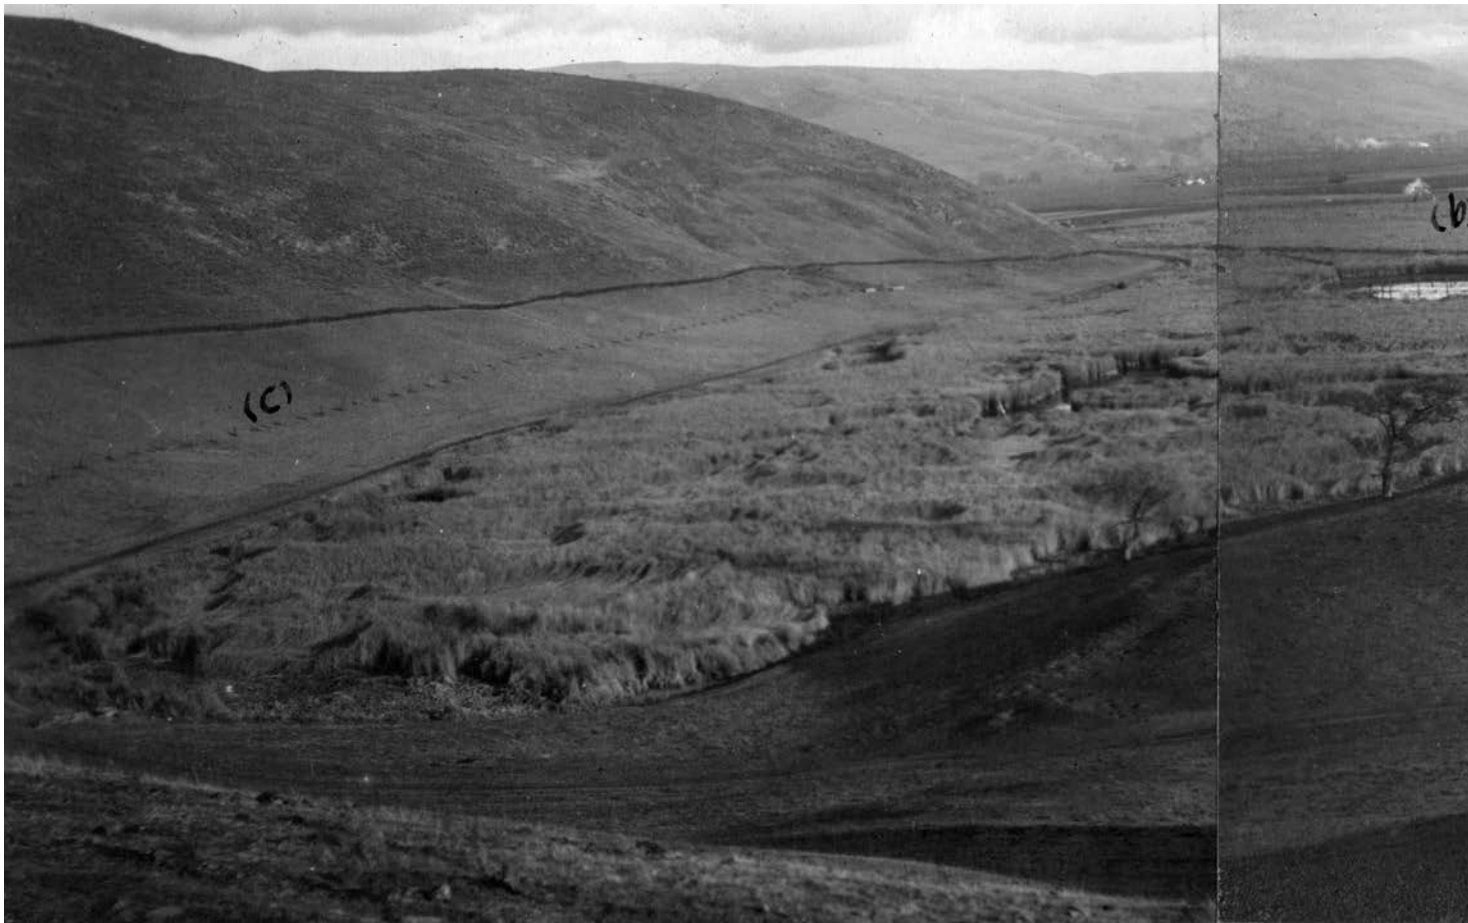
LAGUNA SECA, 1916. Looking southeast across the northern end of the *laguna*: tall tules, open water ponds, Tulare Hill at left (letters on photographs refer to photographer's notes; red circle at extreme left in Laguna Seca map series above shows photographer location).

In Coyote Valley, Laguna Seca offers a rare opportunity to restore natural wetland functions and a diverse wetland habitat mosaic. Laguna Seca restoration would link to existing buffers and have regional significance as a large, natural, valley floor wetland. Successful wetland restoration at Laguna Seca could support a wide range of valued species, including rare plants, amphibians, and water birds.

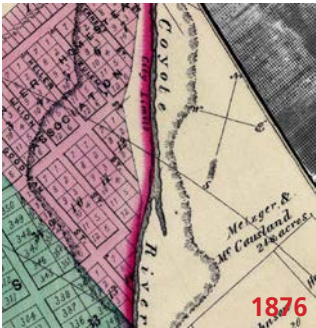
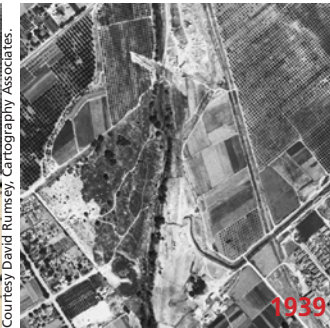
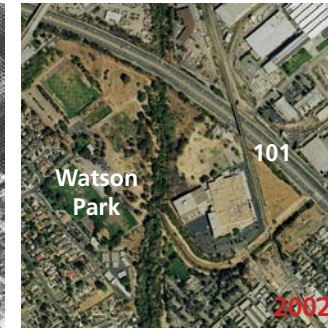
A ONCE-BROAD CHANNEL AREA with wide inset stream benches becomes a city landfill and then Watson Park.

(BELOW) DOTTED LINE IDENTIFIES AREAS OCCUPYING FORMER STREAM BENCHES.

Coyote Creek displayed a natural pattern of long, broad reaches with adjacent inset benches and terraces interspersed with narrow, more confined reaches. This pattern suggests appropriate places for floodplain restoration projects to increase flood capacity.

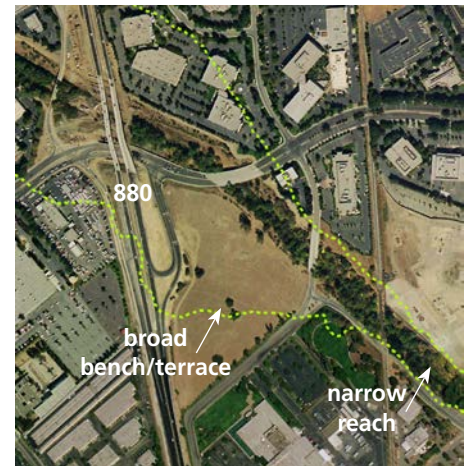
STREAM BENCHES—COYOTE CREEK'S NATURAL MORPHOLOGY REVEALS FLOOD PROTECTION OPPORTUNITIES

Existing flood-prone benches provide potential flood capacity. In the Mid-Coyote reach, there are many broad stream benches still subject to flooding. A number of these areas remain in public ownership, some of which could be designed to support and benefit from occasional flooding.
