SEISMIC STABILITY EVALUATIONS (SSE2)			
Number:	SSE2 – TM – 1LN		
Subject:	Initial Review of Available Data for Lenihan Dam		
Prepared by:	Robert Kirby, PE, GE Richard Harlan, PG, CEG	Date:	11/24/2010
Reviewed by:	Yoshi Moriwaki, PE, GE Guilaine Roussel, PE	Date:	11/24/2010

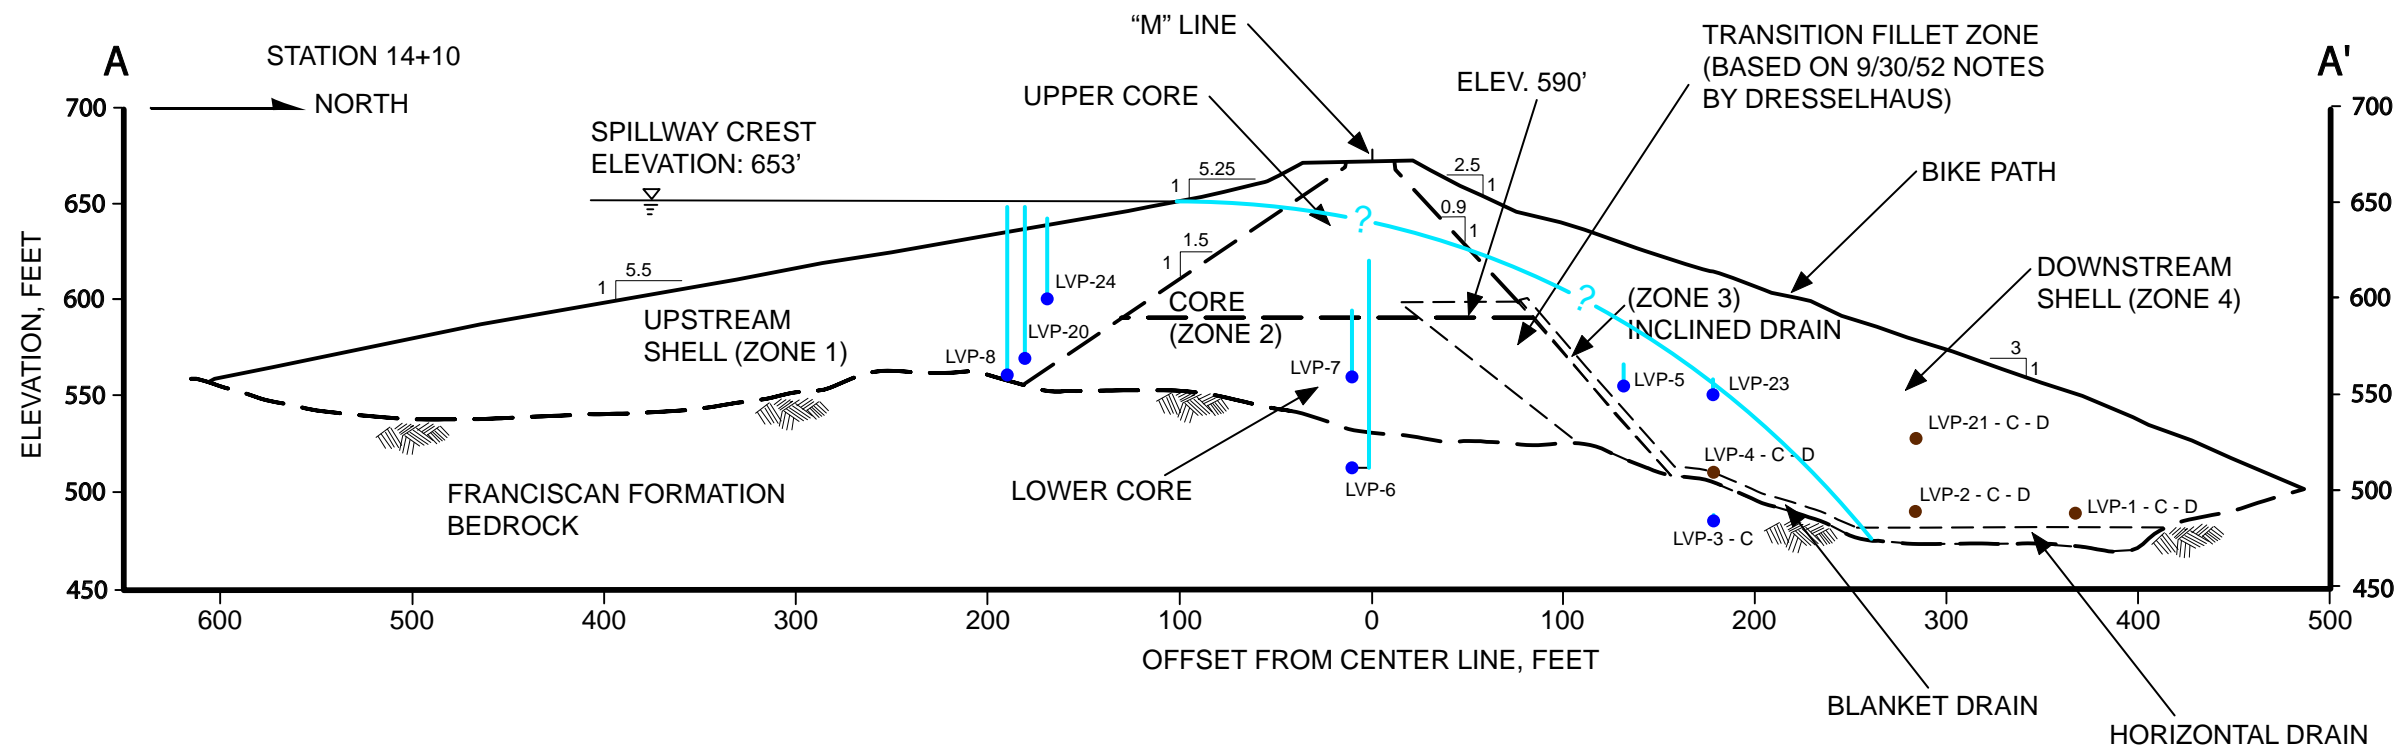
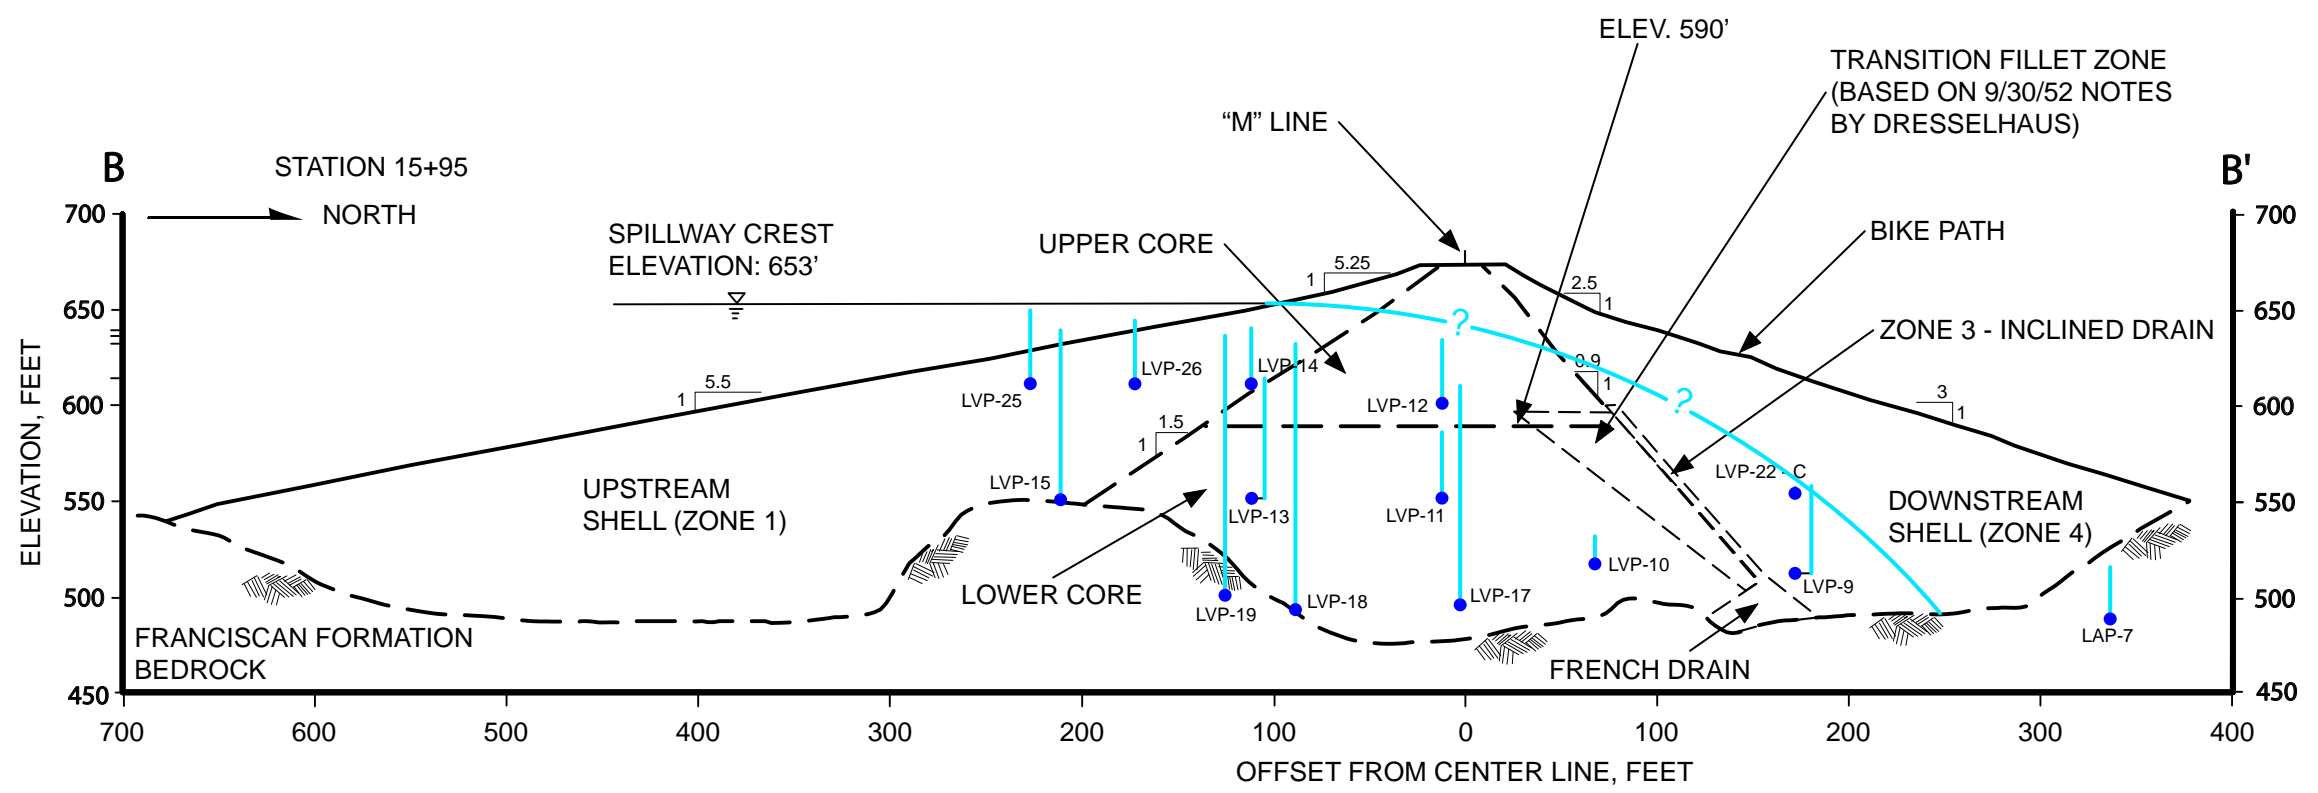
TOP FLOW LINE SHOWN IS APPROXIMATE, PARTICULARLY IN VICINITY OF CHIMNEY DRAIN, AND IS AT THE SAME LOCATION ON BOTH SECTIONS.

LVP-19 PROJECTED 30 FT WEST AND IS SCREENED IN EMBANKMENT

As shown in Figure 2, Lenihan Dam was constructed as a compacted earth dam with upstream and downstream shells, core and drainage zones. The dam is about 195 feet high as measured from the lowest point in the foundation beneath the axis to the crest, and about 207 feet high as measured from the lowest point of the downstream toe to the crest.

The following Table 1 provides a summary of Atterberg limits and sieve analyses data for the zones of the dam shown on Figure 2, and a description of the material classification of each zone. These data were compiled by DSOD and presented in their Memorandum of Design Review (DSOD, 2006).

The piezometer data summarized on Figure 2 show that total heads in the downstream shell (Zone 4) immediately downstream of the inclined drain (Zone 3) are at approximate Elev. 558 feet but that piezometers also located within the downstream shell, but further downstream, are dry. These measured total heads indicate that the inclined drain may not be working as effectively as would be expected. Other important observations from the piezometer data in Figure 2 are that the measured total heads in the rock foundation are relatively high beneath the core and may indicate that the Franciscan Complex bedrock is more permeable than the lower core. A preliminary estimate of the phreatic surface (top flow line) is shown on Figure 2. Finite element seepage analyses will be made in order to provide analytical estimates of the location of the phreatic surface and the distribution of total heads within the embankment. Parametric seepage analyses will be necessary to evaluate what embankment, bedrock and drain permeabilities are consistent with the measured values of total head.

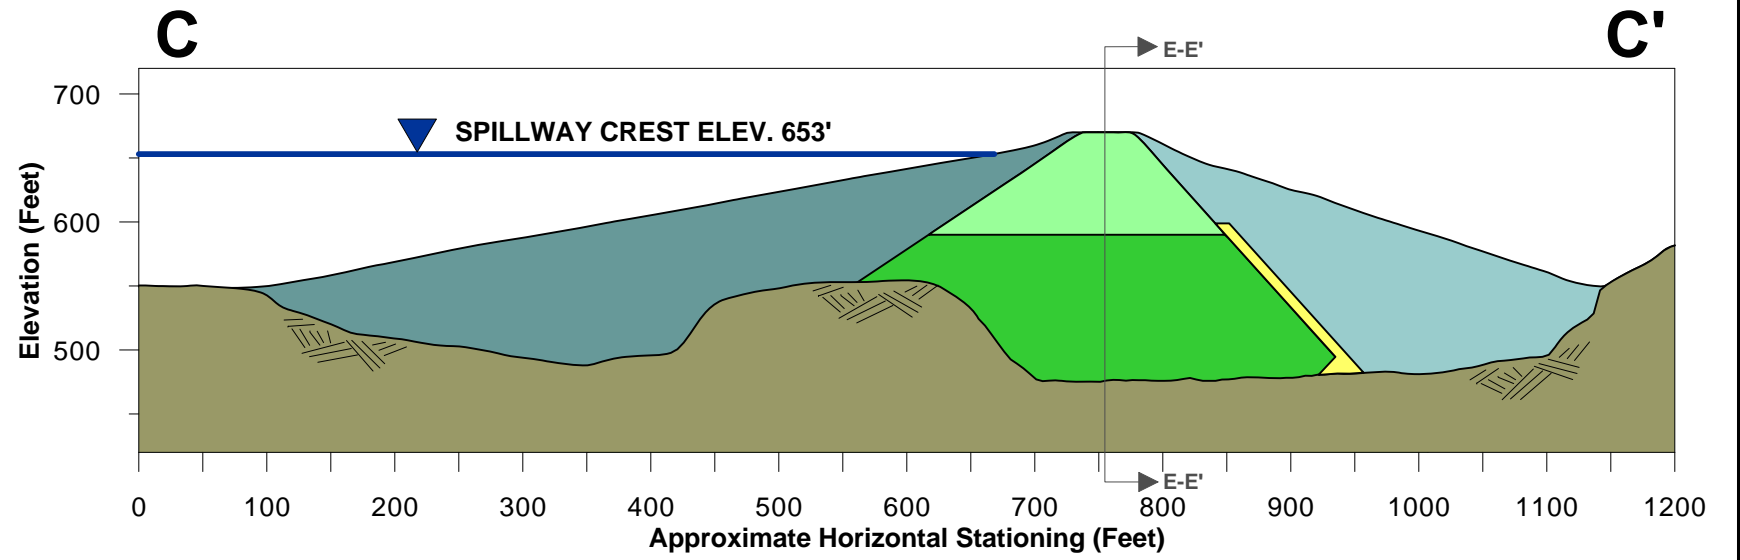
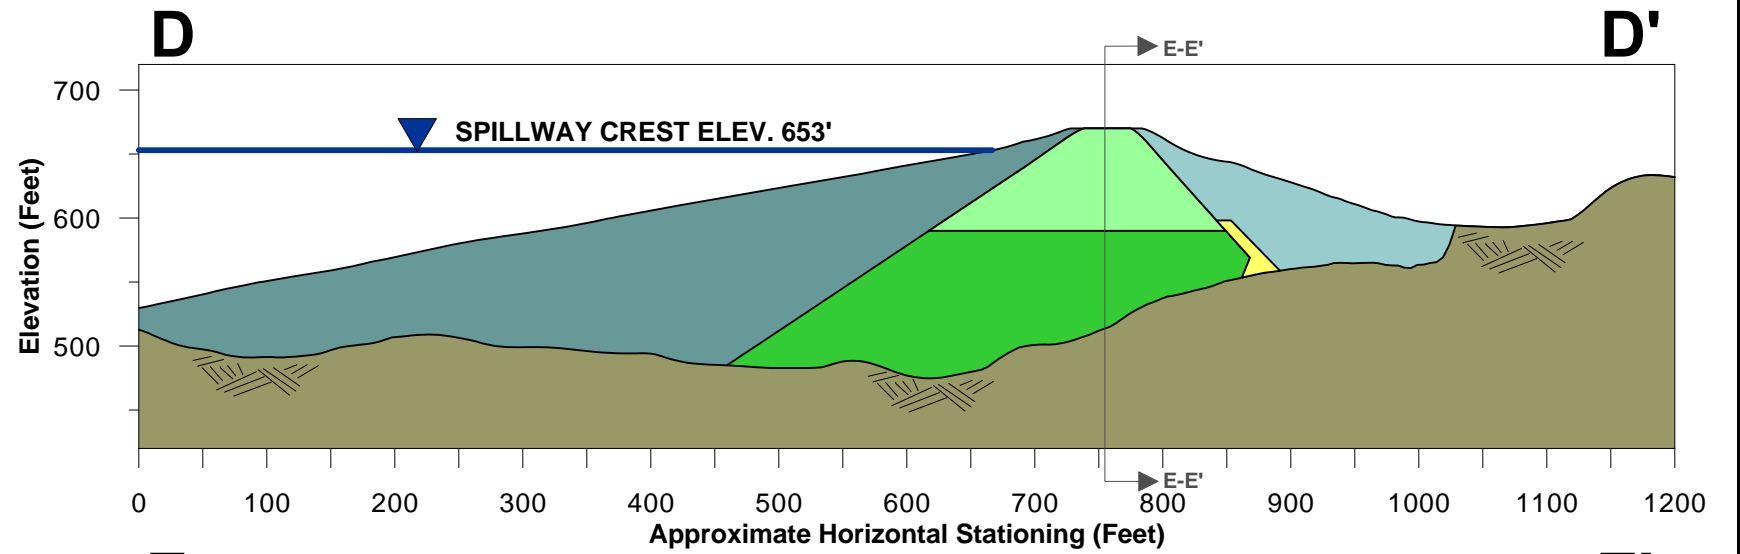
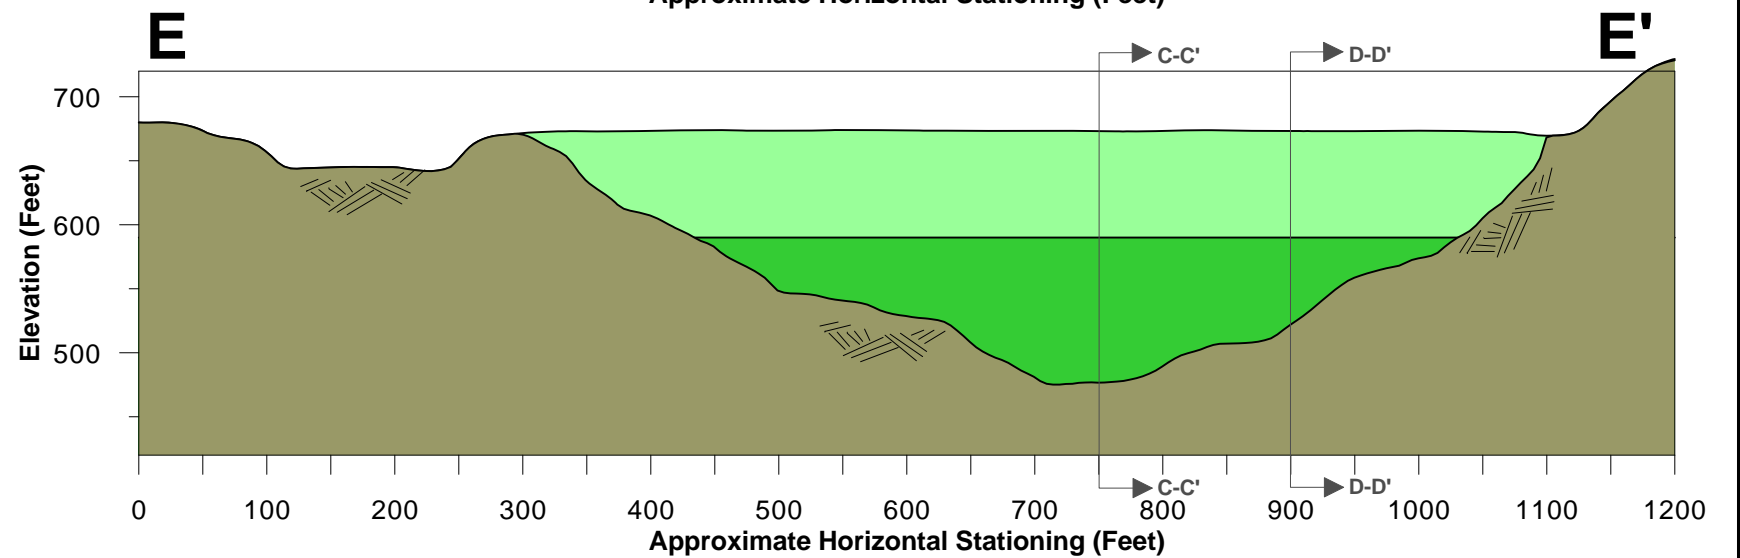
CROSS SECTION LOCATION MAP

- Upstream Shell (Zone 1)
- Lower Core (Zone 2, Below El. 590)
- Upper Core (Zone 2, Above El. 590)
- Drain Zone (Zone 3)
- Downstream Shell (Zone 4)
- Franciscan Complex Bedrock

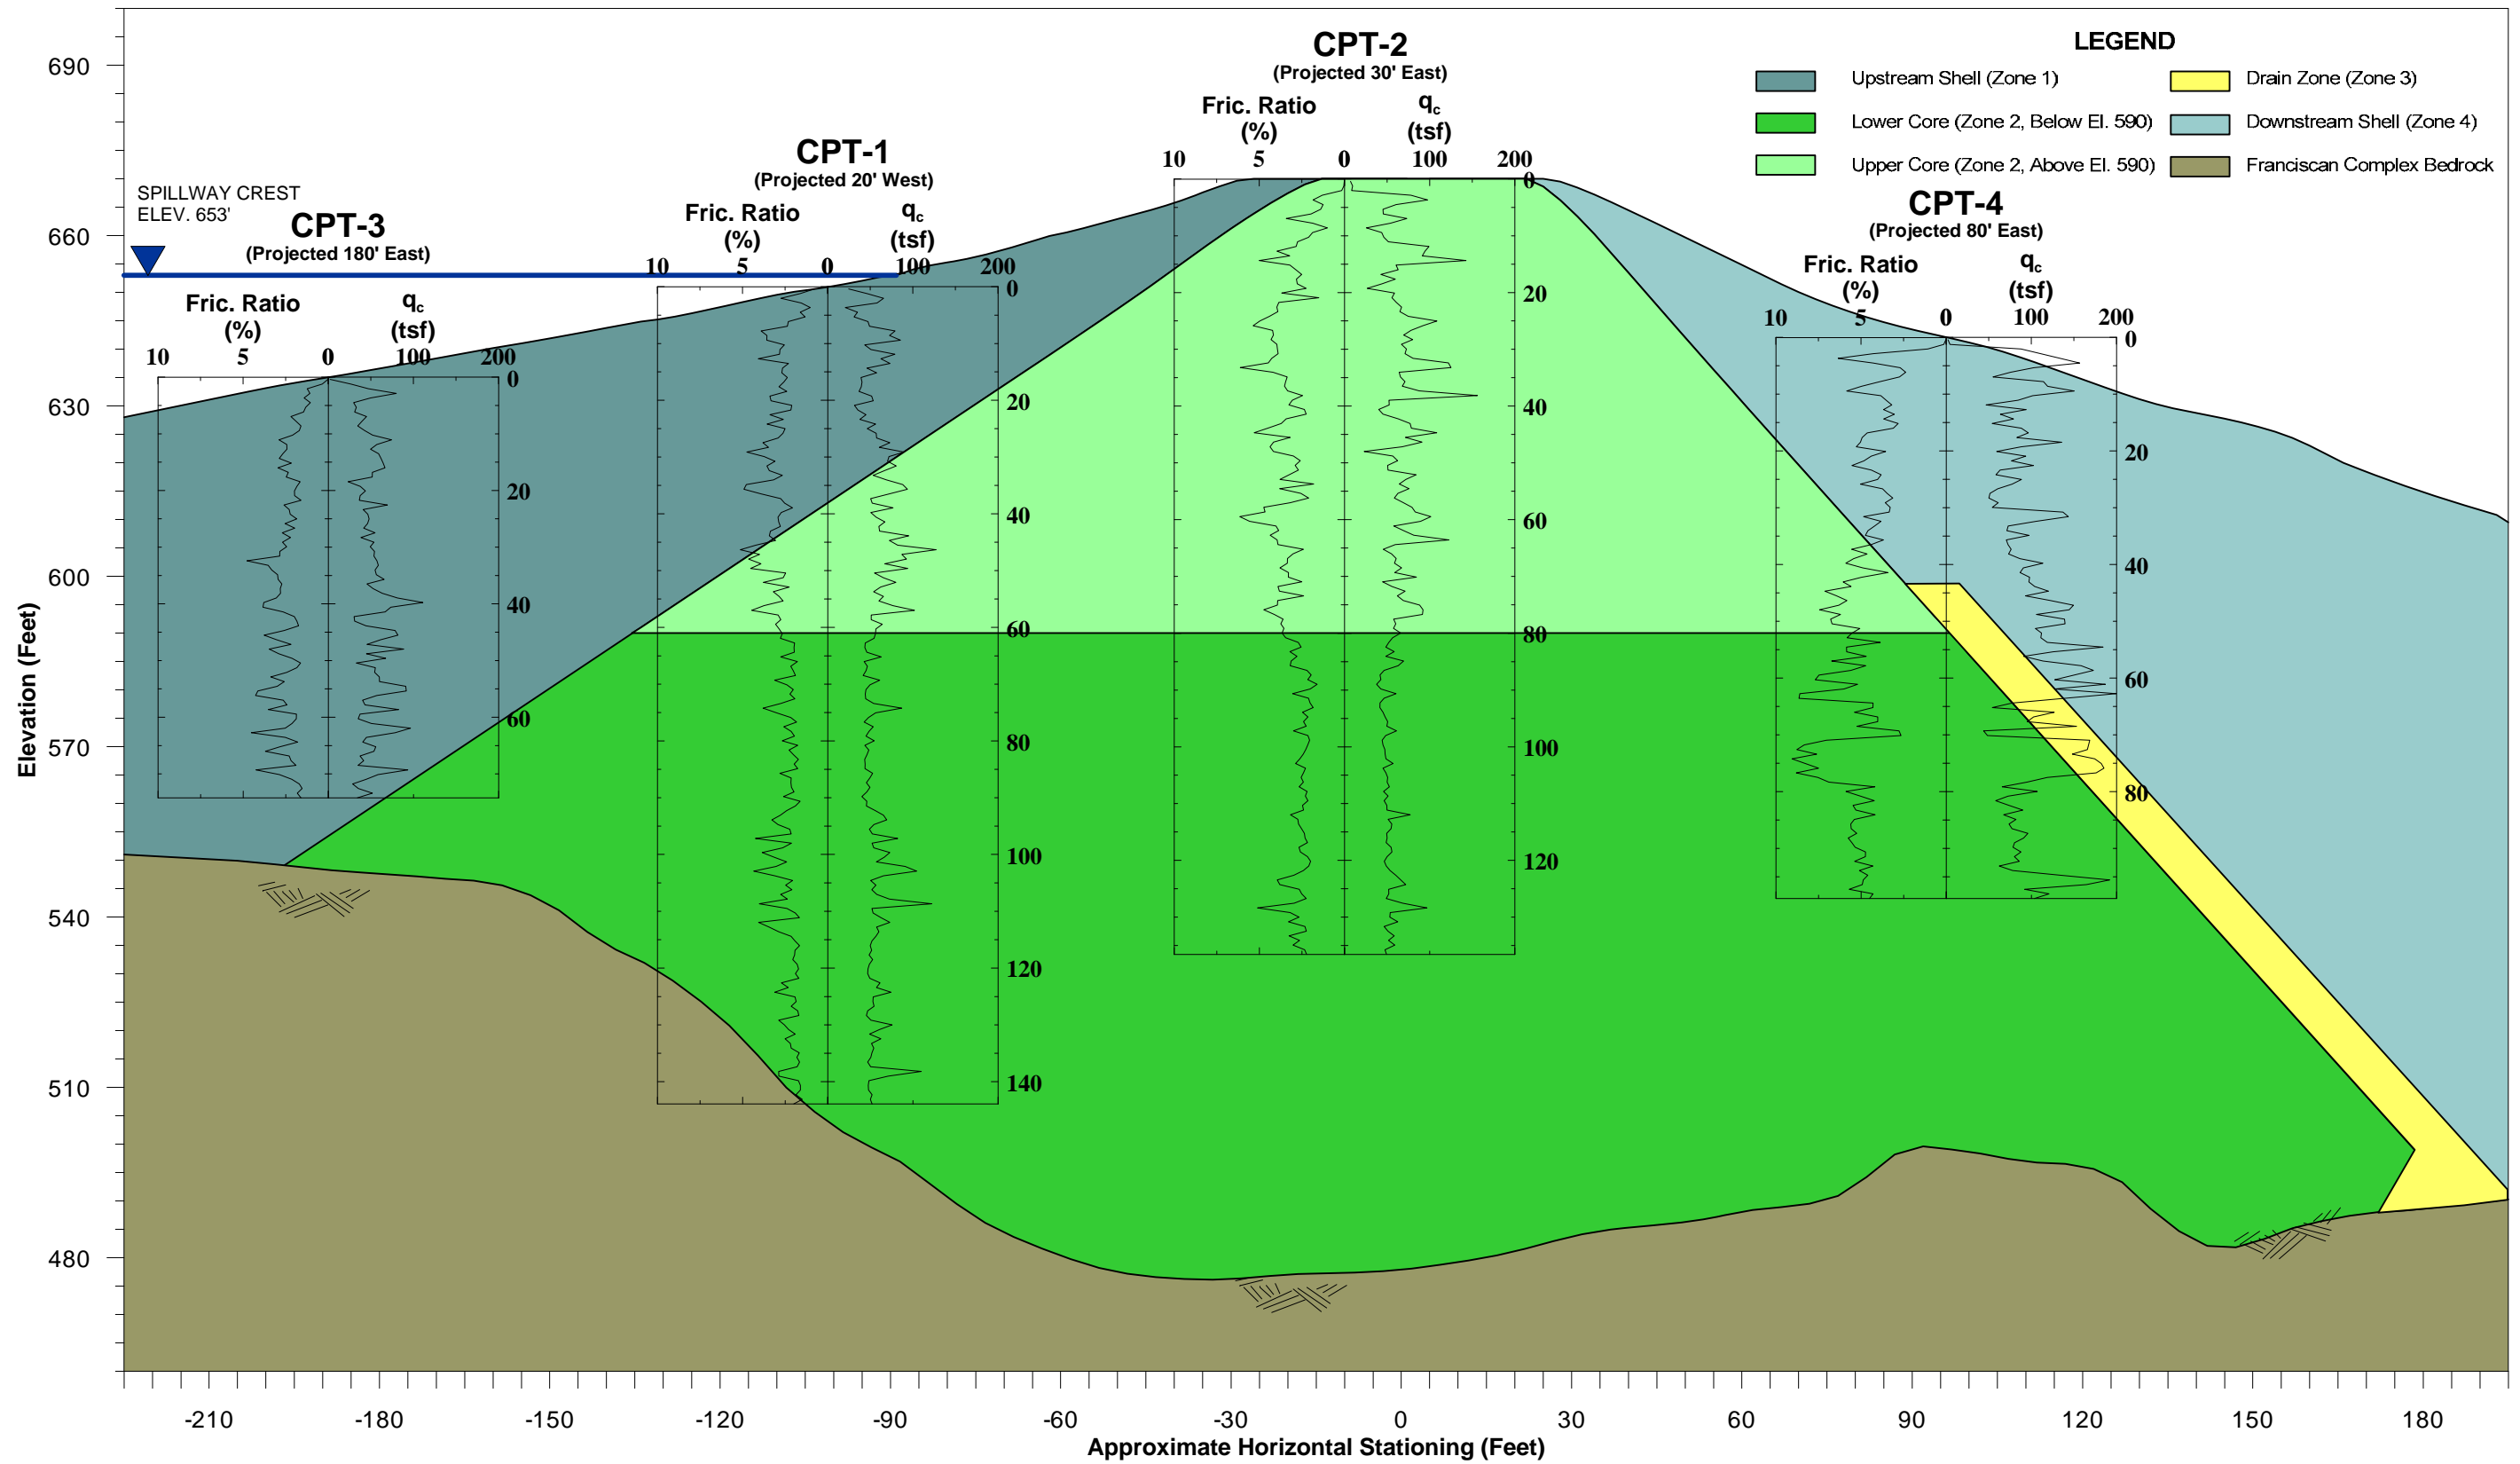
Note: See Figure 2 for complete zoning, piezometric data and location of section B-B'

The Lenihan Dam Outlet Investigation by RLVA (1999) included four CPTs at the locations shown on Figure 1B. As shown on Figure 1B, CPT-1, CPT-2 and CPT-4 were completed along the alignment of the outlet pipeline in the vicinity of Section B-B' on the upstream slope, dam crest, and downstream slope, respectively. CPT-3 was completed on the upstream slope in the vicinity of Section A-A', as also shown on Figure 1B. RLVA analyzed the CPT data from these four CPT probes and estimated engineering properties of the embankment soils using relationships presented by Robertson and Campanella (1990). These relationships have been refined in recent years as described by Robertson (2009). This section discusses some of the inferred properties of the soils at the site based on the results of these CPT test data using the more recent correlations by Robertson (2009).

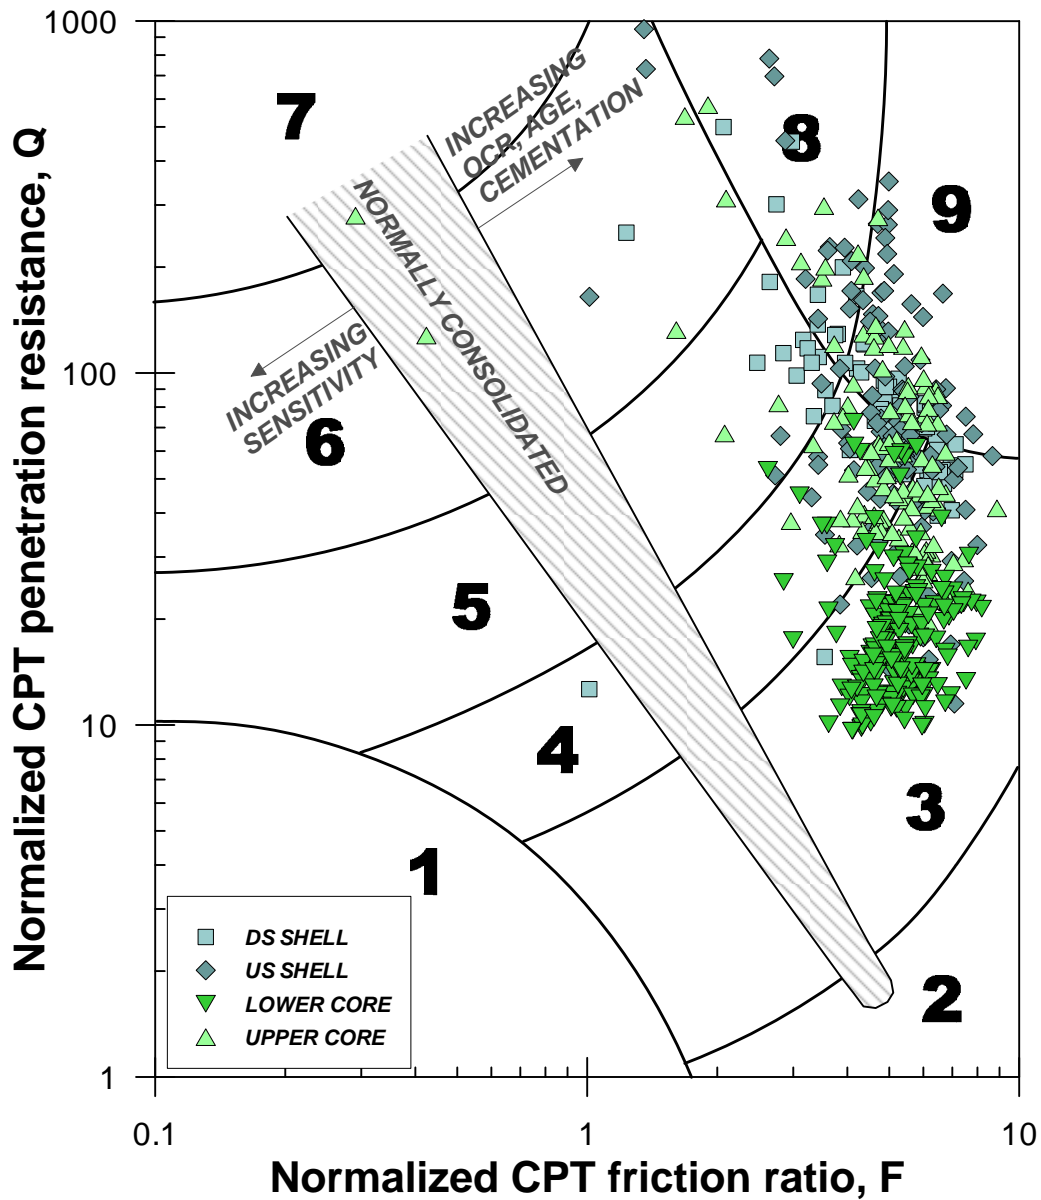
Zone	Soil Behavior Type	I_c
1	Sensitive, fine grained	N/A
2	Organic soils – peats	> 3.6
3	Clays – silty clay to clay	2.95 – 3.6
4	Silt mixtures – clayey silt to silty clay	2.60 – 2.95
5	Sand mixtures – silty sand to sandy silt	2.05 – 2.6
6	Sands – clean sand to silty sand	1.31 – 2.05
7	Gravelly sand to dense sand	< 1.31
8	Very stiff sand to clayey sand*	N/A
9	Very stiff, fine grained*	N/A

Notes: Soil Behavior Type Index Chart based on Robertson (2009)

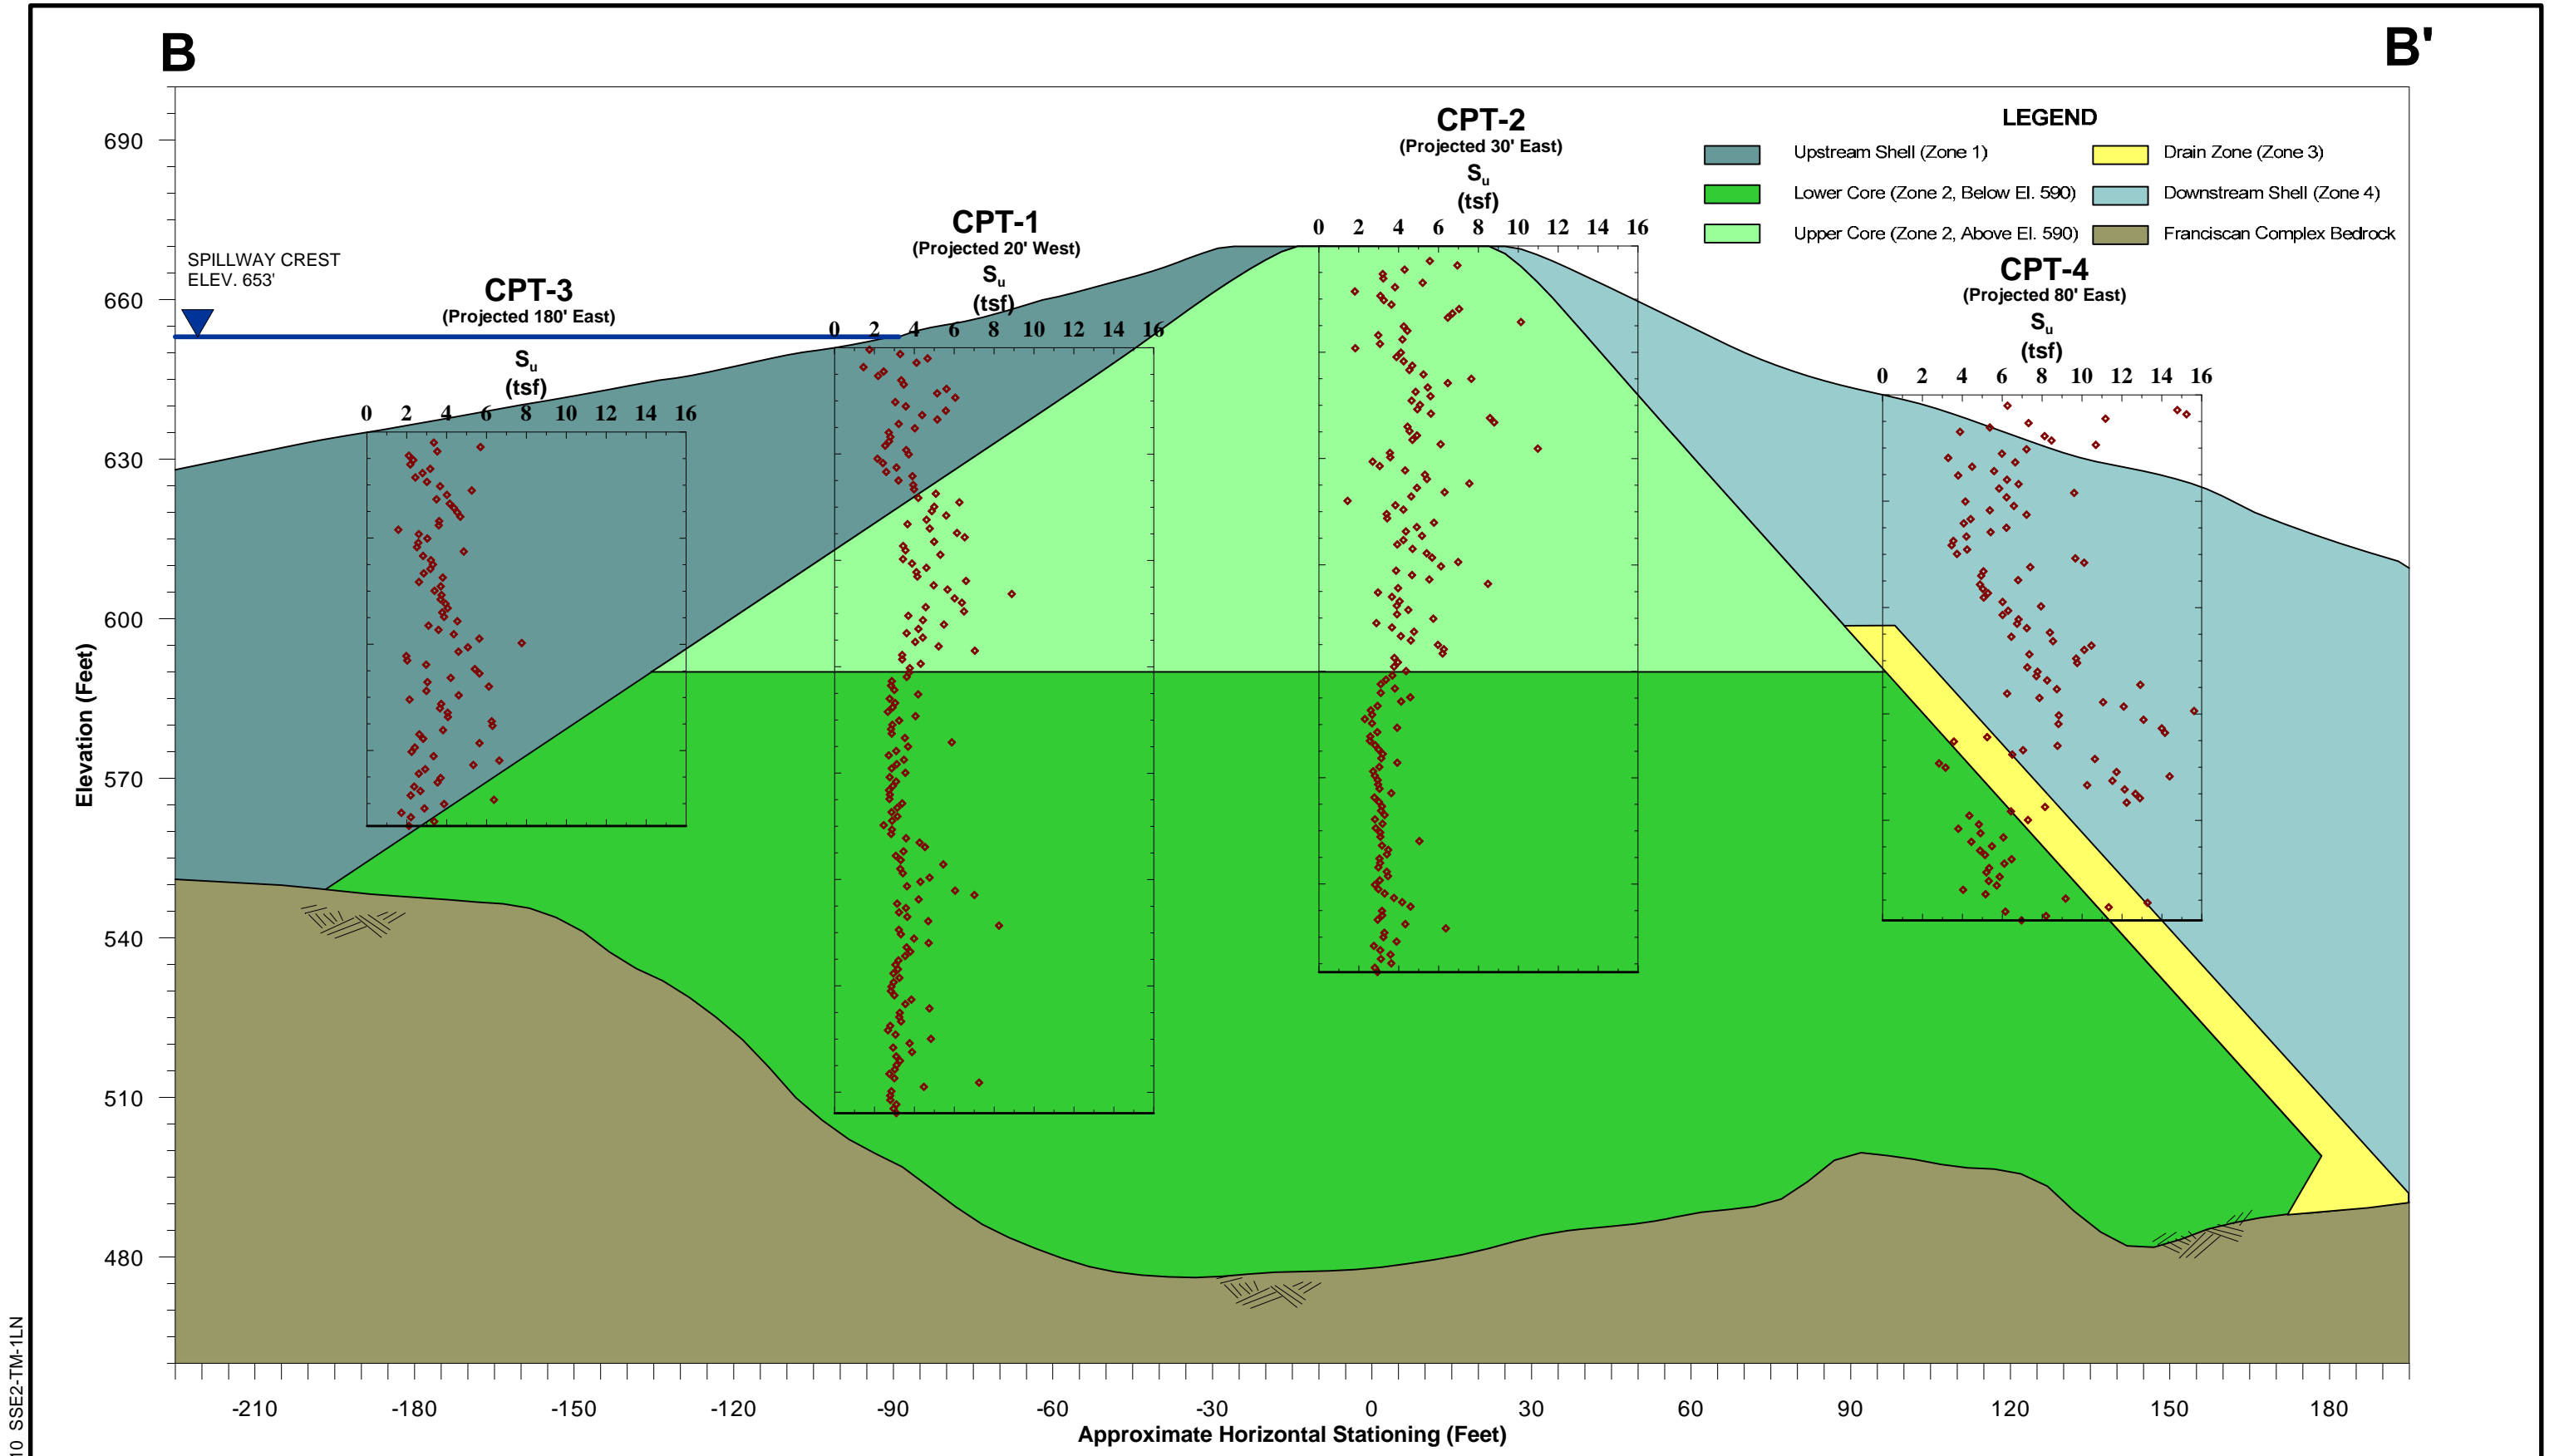
Notes: 1. See Figure 2 for complete zoning, piezometric data and location of section B-B'
 2. Inferred Undrained Shear Strength, S_u based on Robertson (2009)
